# Greater Shepparton City Council

## Tallygaroopna Flood Scoping Study Final Report

February 2024

Project	Tallygaroopna Flood Scoping Study
Client	Greater Shepparton City Council
Client's Representative	Alex Smith / Jennifer Brewis
Confluence Group Project Manager	Trevor Clark

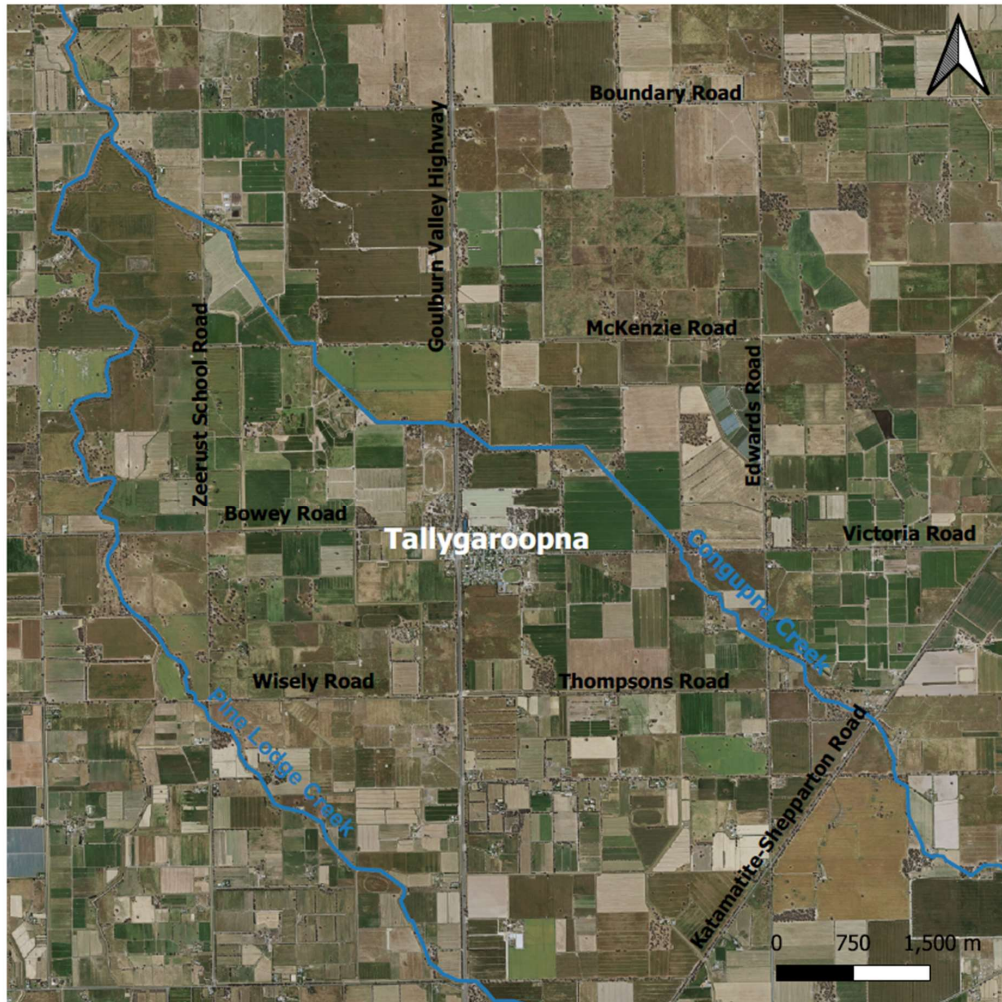
**Figure 1 Local Area Plan**

The nearest waterways are Congupna Creek and Pine Lodge Creek. Both these creeks flow generally in a north west direction. The creeks have been significantly modified as engineered trapezoidal shaped open drains.

The creeks receive inflows from their local catchment areas, including incoming Goulburn Murray Water (GMW) rural drains. They also receive inflows from the Broken River when the river is in major flood such as occurred in October 1993.

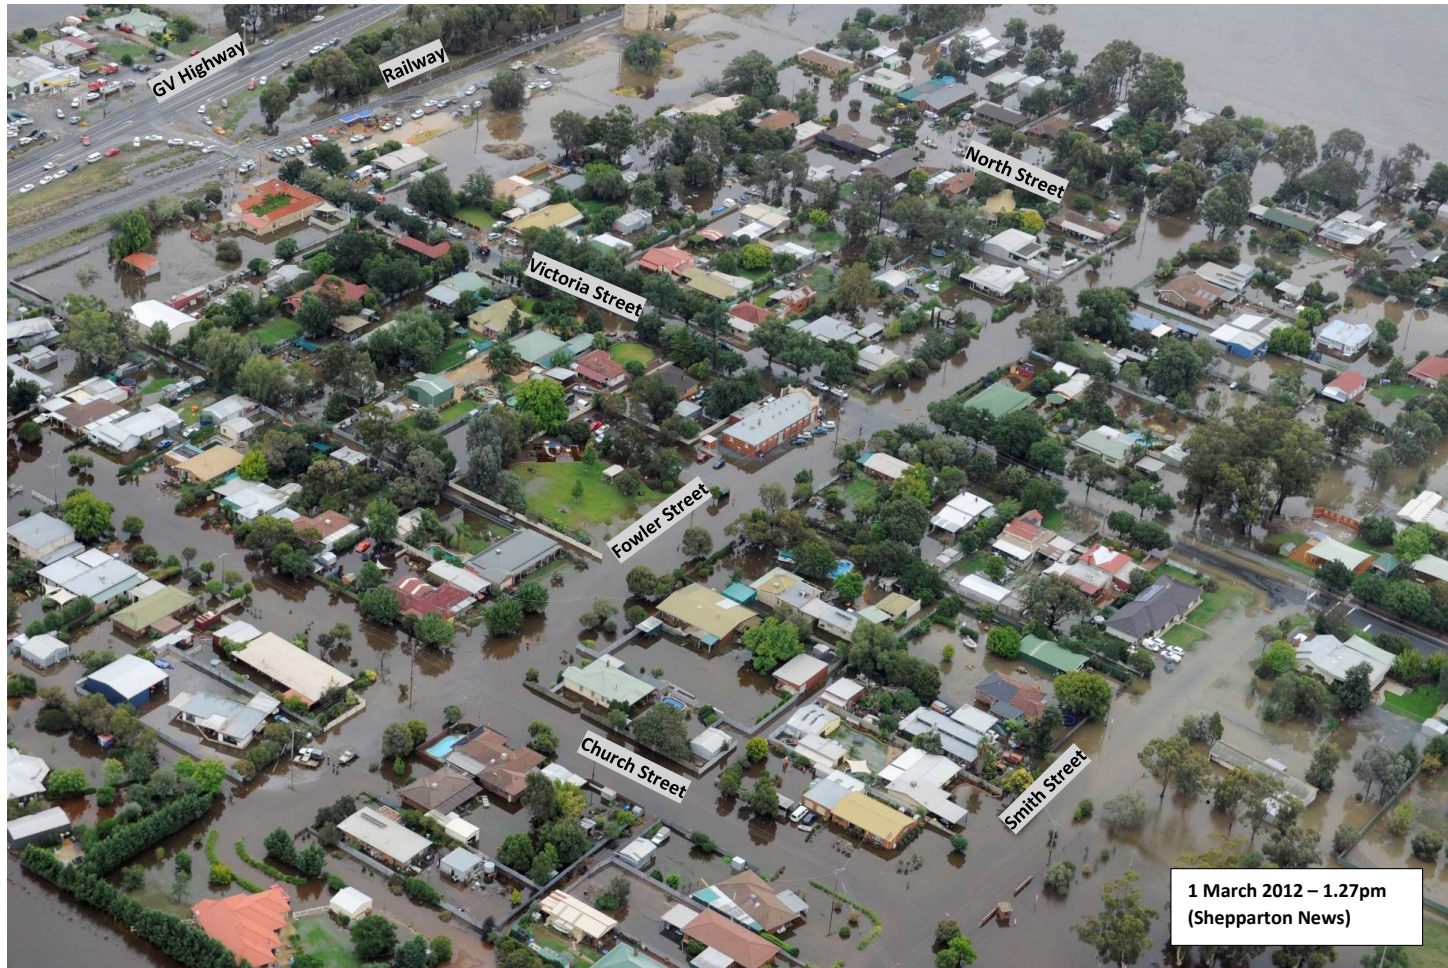
Figure 5 Aerial Photograph 1 – 1 March 2012 Flood

- Oblique aerial photography of the 2012 flood as shown on Figures 5 and 6 (acquired by Shepparton News, 1 March 2012).
- Vertical aerial photography of the 2012 flood supplied by the Goulburn Broken CMA (acquired on the 5 March 2012). This imagery is shown below in Figure 8.
- Vertical aerial photography of the October 1993 flood (HydroTechnology, 1995). This imagery is shown in Figure 9.

Although rainfall for the 24 hours to 9am on the 1 March 2012 was not as high as that compared to the 24 hours to 9am on the 28 February, flooding at Tallygaroopna is expected to have been more severe on the 1 March due to the catchment being in a saturated condition prior to the rainfall. Media reports at the time would appear to support this. Shepparton News acquired aerial photographs taken just after 1pm on the 1 March 2012 show widespread inundation in parts of the town (refer to Figures 5 and 6). Anecdotal accounts would suggest that the aerial photography was taken close to the peak of flooding.

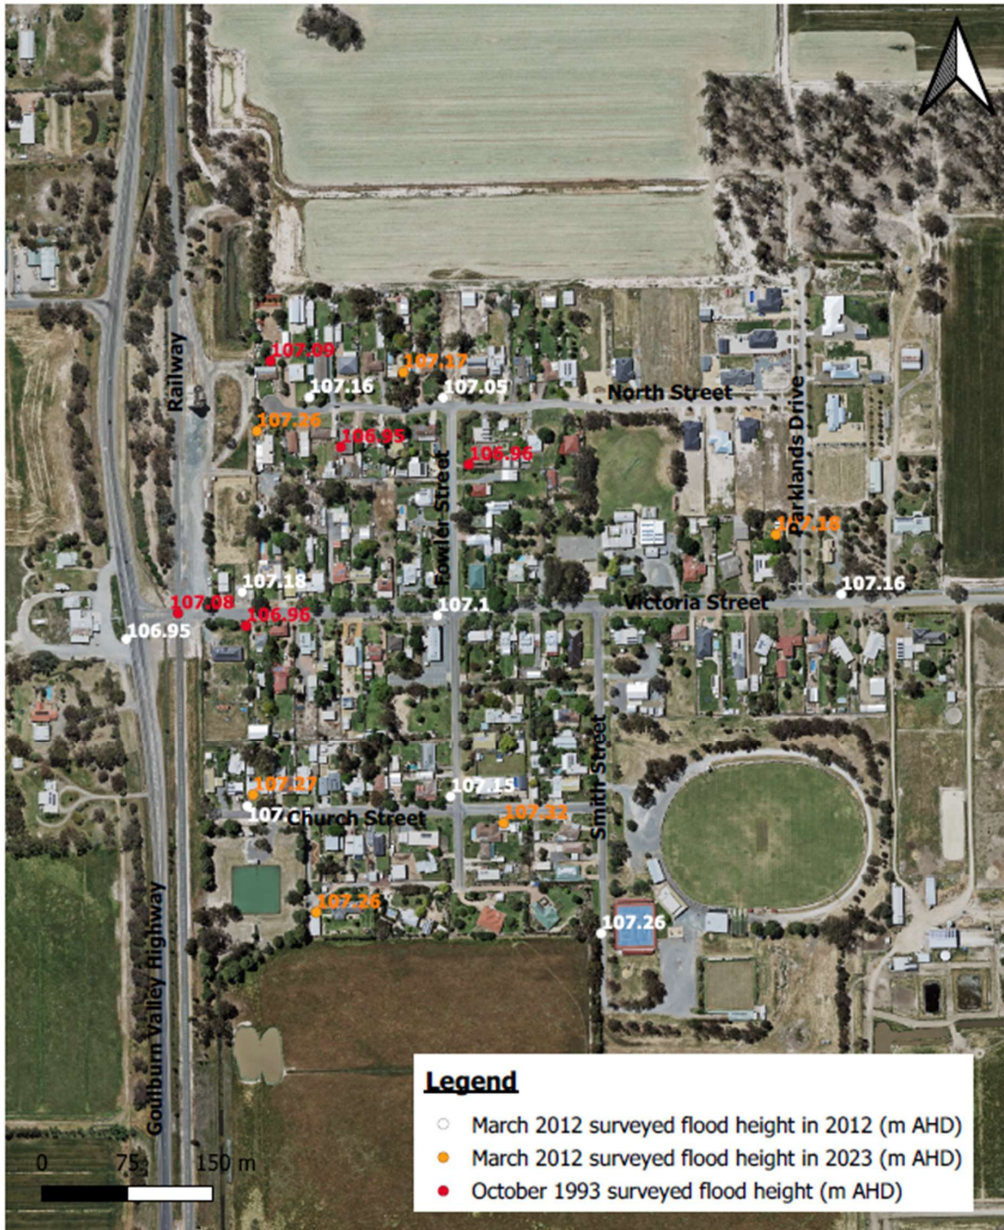
Figure 7 Recorded Flood Height Marks

- Nine marks for the March 2012 flood surveyed in 2012:
  - Eight marks located upstream of the railway
  - Eight marks vary from 107.05 to 107.26 m AHD
  - Average height for the eight marks is 107.15 m AHD
  - One mark located downstream of the railway – 106.95 m AHD
- Six marks for the March 2012 flood surveyed in 2023:
  - All six marks located upstream of the railway
  - Six marks vary from 107.17 to 107.32 m AHD
  - Average height for the six marks is 107.24 m AHD
- Five marks for the October 1993 flood:
  - All five marks located upstream of the railway
  - Five marks vary from 106.95 to 107.09 m AHD
  - Average height for the five marks is 107.01 m AHD

The average height of the above 2012 flood height marks is 0.16 m higher than the average height for the 1993 recorded flood height marks.

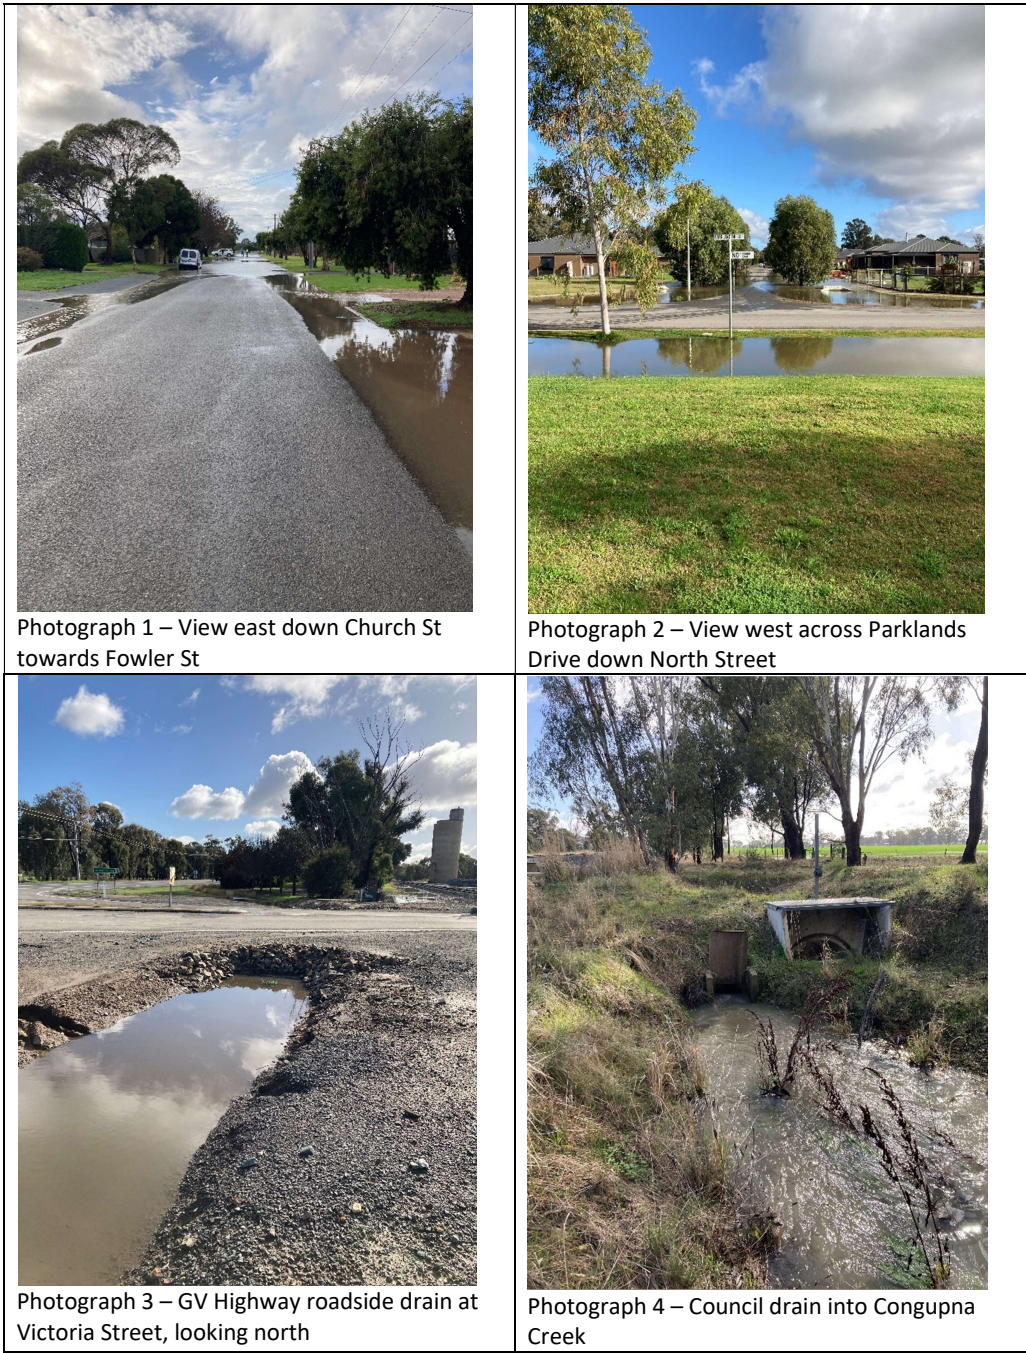
**Figure 11      Photographs – 8 June 2023 Flood Event**

An on-site inspection at Tallygaroopna between 9am and noon on the 8 June 2023 revealed the following (refer to Figure 11):

- Significant roadway flooding in Church Street
- Rural runoff inflows into the town system at Smith Street opposite the netball courts
- Rural runoff flows into the town system at the east boundary of the Recreation Reserve
- Flows in the open drains within the railway and highway corridor moving very slowly
- Extensive roadside flooding in Parklands Drive and the east end of North Street
- Parklands Estate basin full, township basin empty

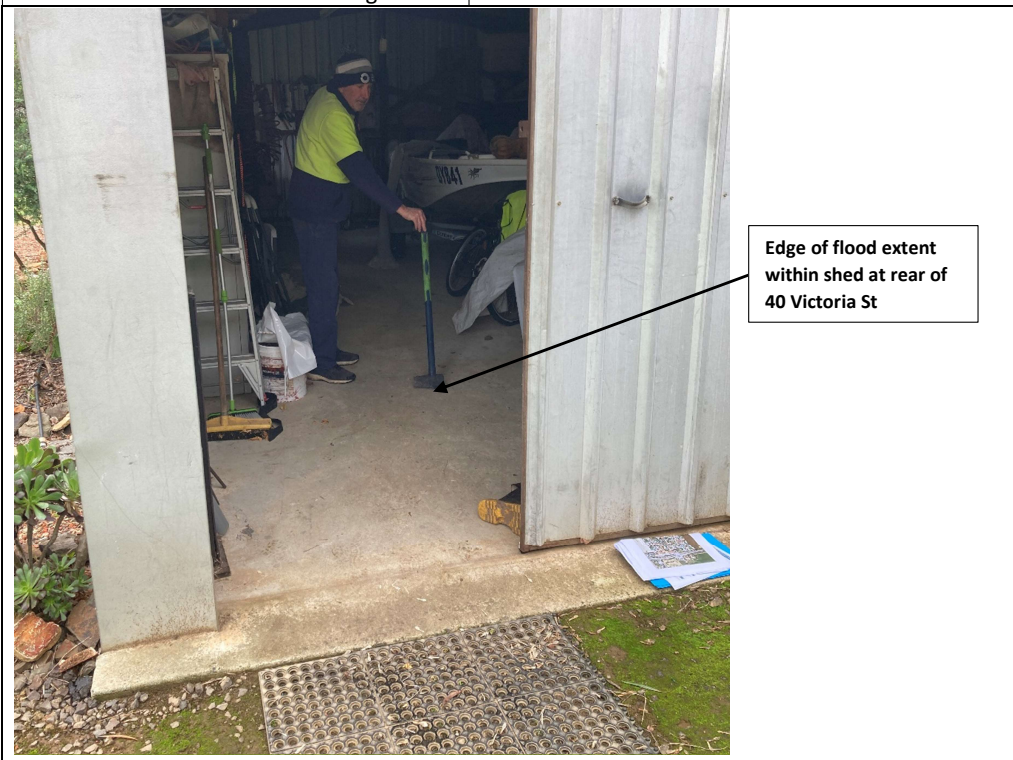
Flood Mark No.	<b>FM2023 – T1</b>
Date of interview / Inspection	27 June 2023
Address	40 Victoria Street
Flood Description	2012 flood - where floodwaters got to on the concrete floor of this rear shed.
Reliability	Medium
Flood Level (m AHD)	107.18
MGA Zone 55 Coordinate - easting	359627
MGA Zone 55 Coordinate - northing	5988489

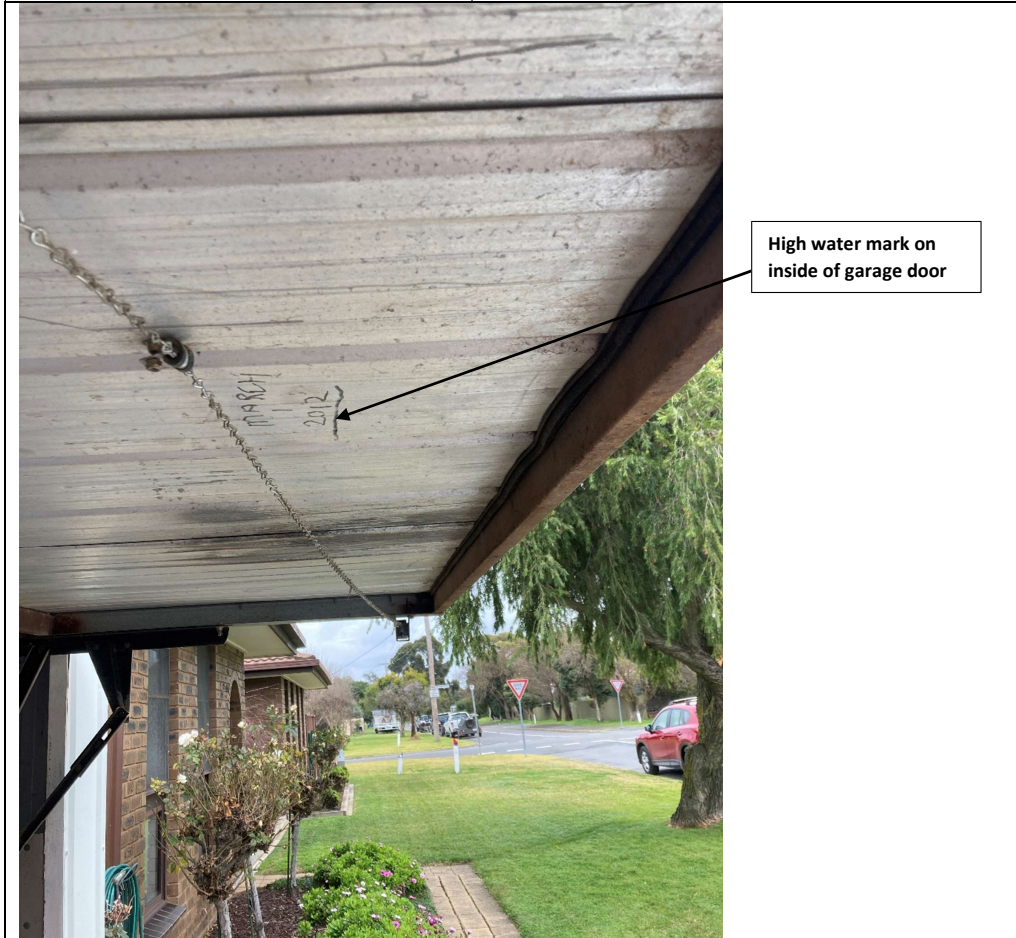
Flood Mark No.	<b>FM2023 – T2</b>
Date of interview / Inspection	27 June 2023
Address	17 Fowler Street
Flood Description	2012 flood – high water mark on the inside of this garage door – 0.25 m above concrete floor below.
Reliability	High
Flood Level (m AHD)	107.32
MGA Zone 55 Coordinate - easting	359388
MGA Zone 55 Coordinate - northing	5988235

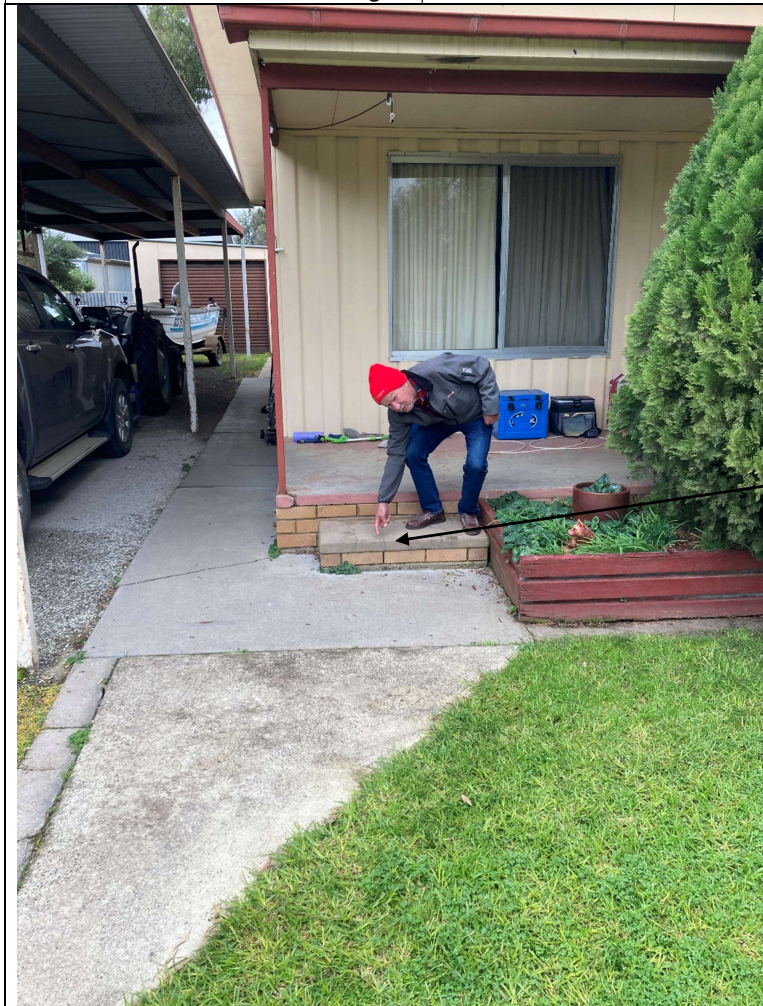
Top of step at 8 Church St

Flood Mark No.	<b>FM2023 – T3</b>
Date of interview / Inspection	27 June 2023
Address	8 Church Street
Flood Description	Peak 2012 flood level equal to the top of the first step up the verandah leading to the house front door.
Reliability	Medium
Flood Level (m AHD)	359169
MGA Zone 55 Coordinate - easting	5988262
MGA Zone 55 Coordinate - northing	107.27

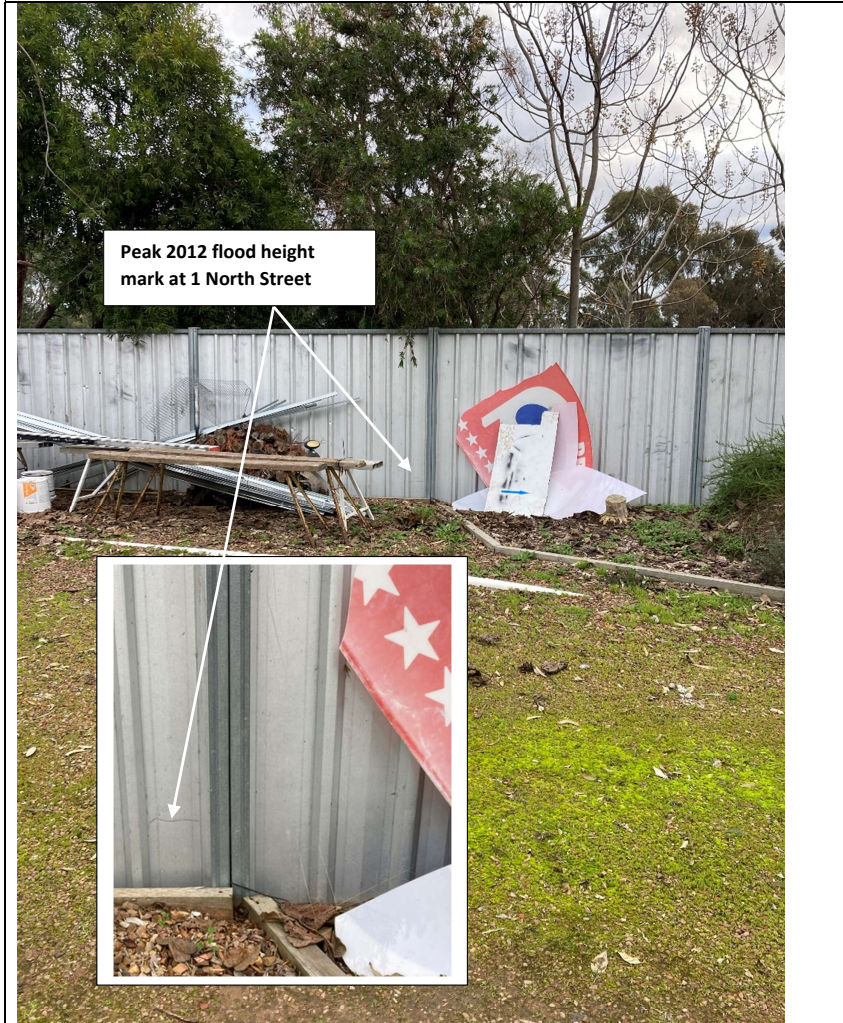
Flood Mark No.	<b>FM2023 – T5</b>
Date of interview / Inspection	12 July 2023
Address	1 North Street
Flood Description	Peak 2012 flood level. Ron recorded the peak at this mark on his side fence.
Reliability	High
Flood Level (m AHD)	107.26
MGA Zone 55 Coordinate - easting	359172
MGA Zone 55 Coordinate - northing	5988579
