Greater Shepparton City Council

Tallygaroopna Flood Scoping Study Final Report

February 2024

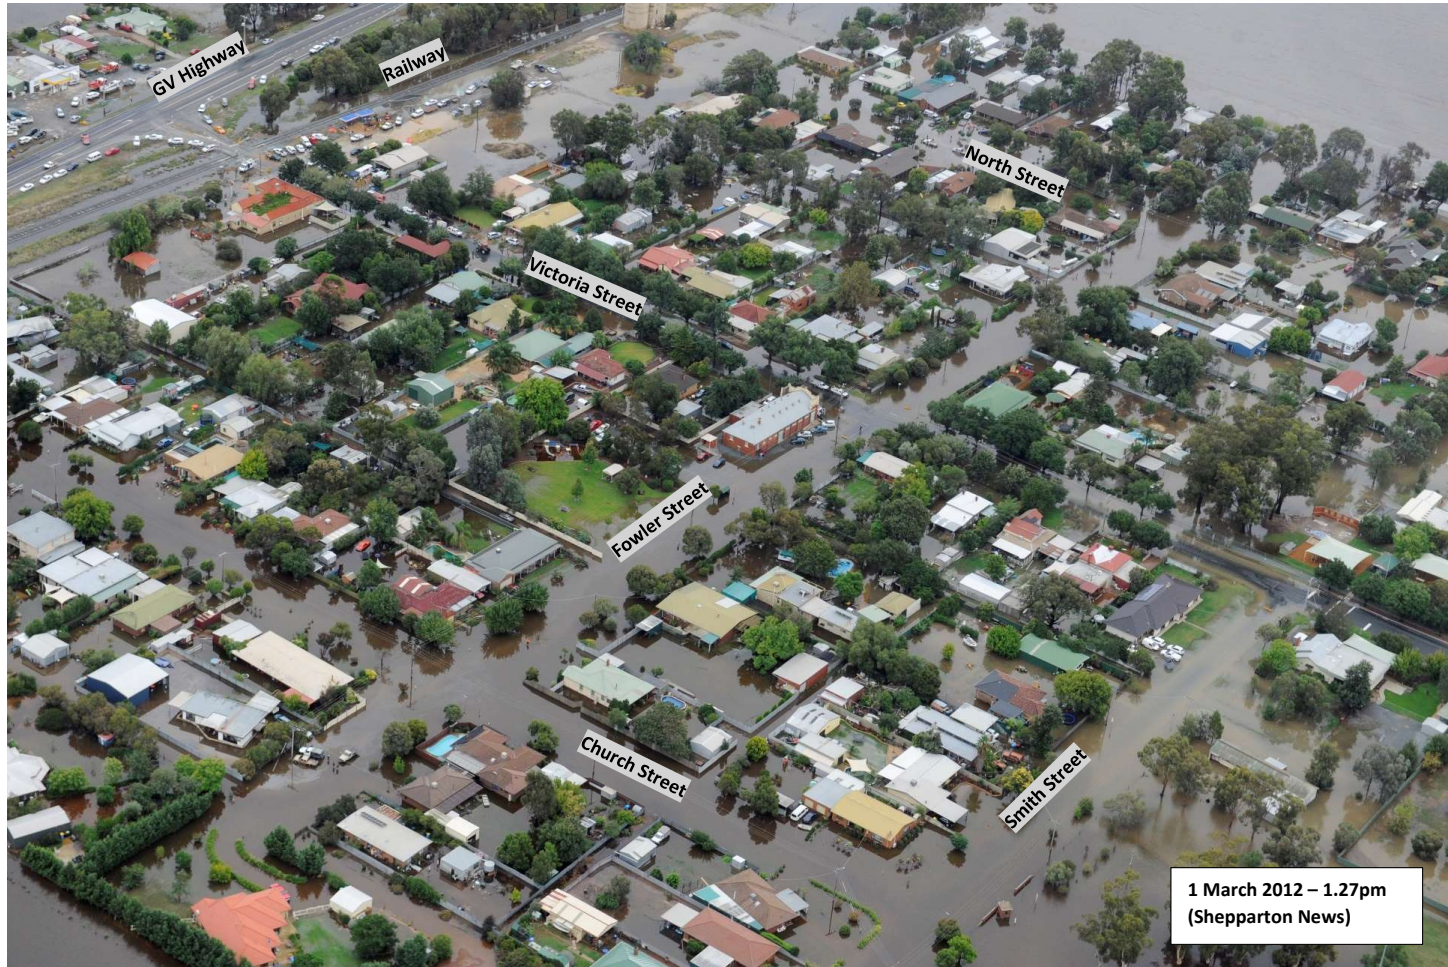
Figure 5 Aerial Photograph 1 – 1 March 2012 Flood

- Oblique aerial photography of the 2012 flood as shown on Figures 5 and 6 (acquired by Shepparton News, 1 March 2012).
- Vertical aerial photography of the 2012 flood supplied by the Goulburn Broken CMA (acquired on the 5 March 2012). This imagery is shown below in Figure 8.
- Vertical aerial photography of the October 1993 flood (HydroTechnology, 1995). This imagery is shown in Figure 9.

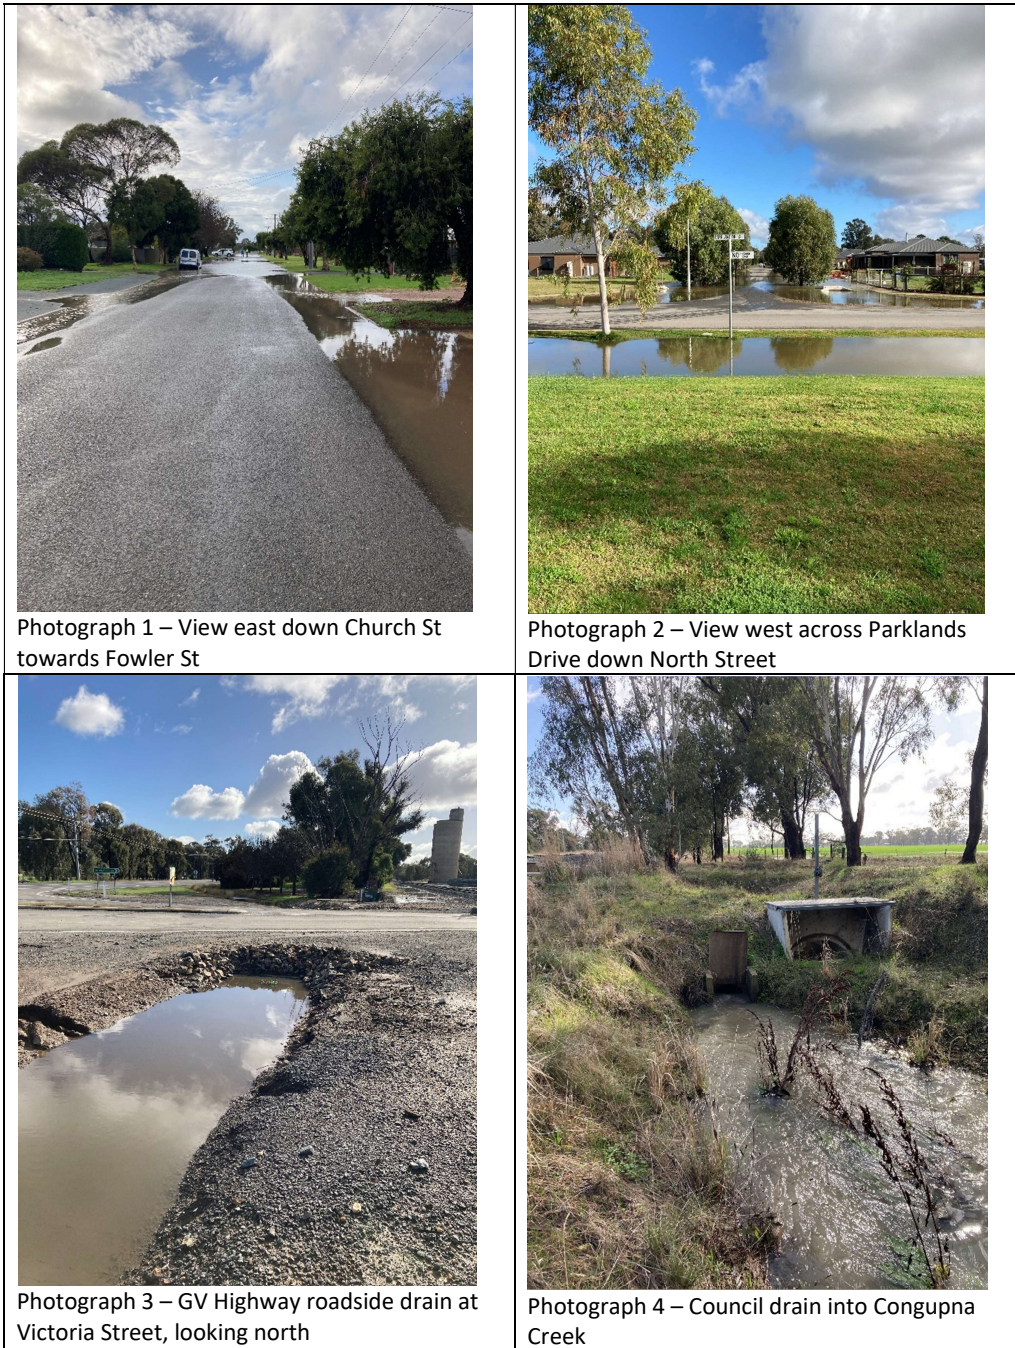
Figure 11 Photographs – 8 June 2023 Flood Event

An on-site inspection at Tallygaroopna between 9am and noon on the 8 June 2023 revealed the following (refer to Figure 11):

- Significant roadway flooding in Church Street
- Rural runoff inflows into the town system at Smith Street opposite the netball courts
- Rural runoff flows into the town system at the east boundary of the Recreation Reserve
- Flows in the open drains within the railway and highway corridor moving very slowly
- Extensive roadside flooding in Parklands Drive and the east end of North Street
- Parklands Estate basin full, township basin empty

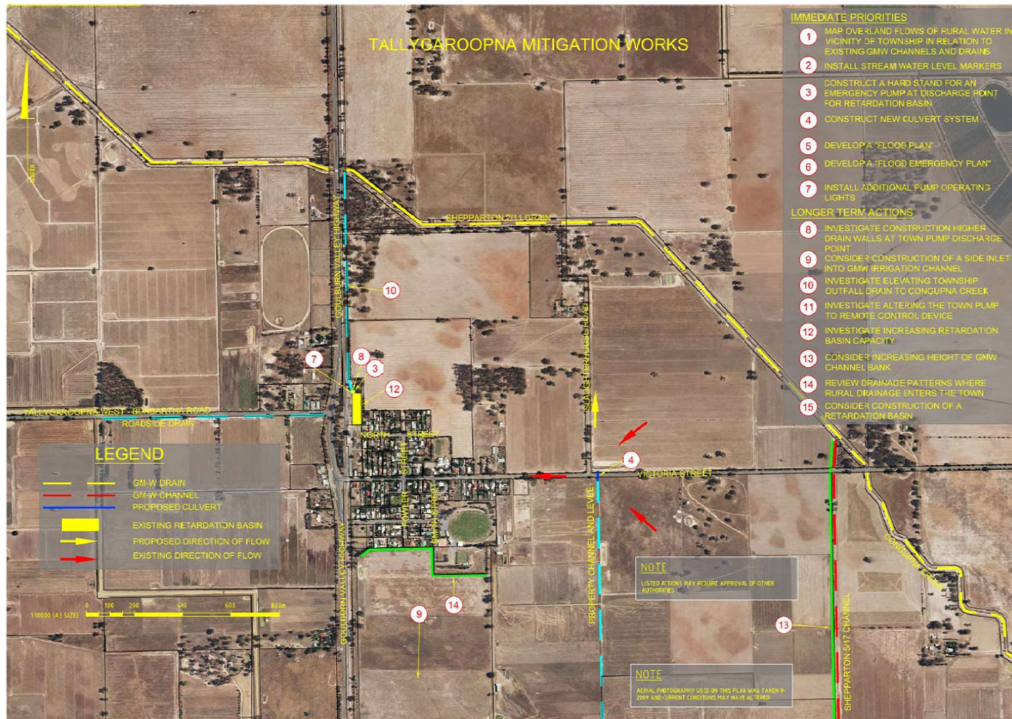
Figure 12 Tallygaroopna Drainage Improvement Plan – Post 2012 Event

- Upgrades to the town's stormwater drainage system including the pipe collector network, the retarding basin storage volume, the retarding basin pump facility and the outfall drain between the basin and Congupna Creek.
- Raising the height of the channel bank at GMW 5/17.
- Construction of a new culvert at Victoria Road / Slaughterhouse Road.
- Review of drainage arrangements where rural runoff enters the town.

Works which are understood to have been completed since 2012 include an upgrade of the Slaughterhouse Road drain, and raising of the GMW Channel 5/17 bank.

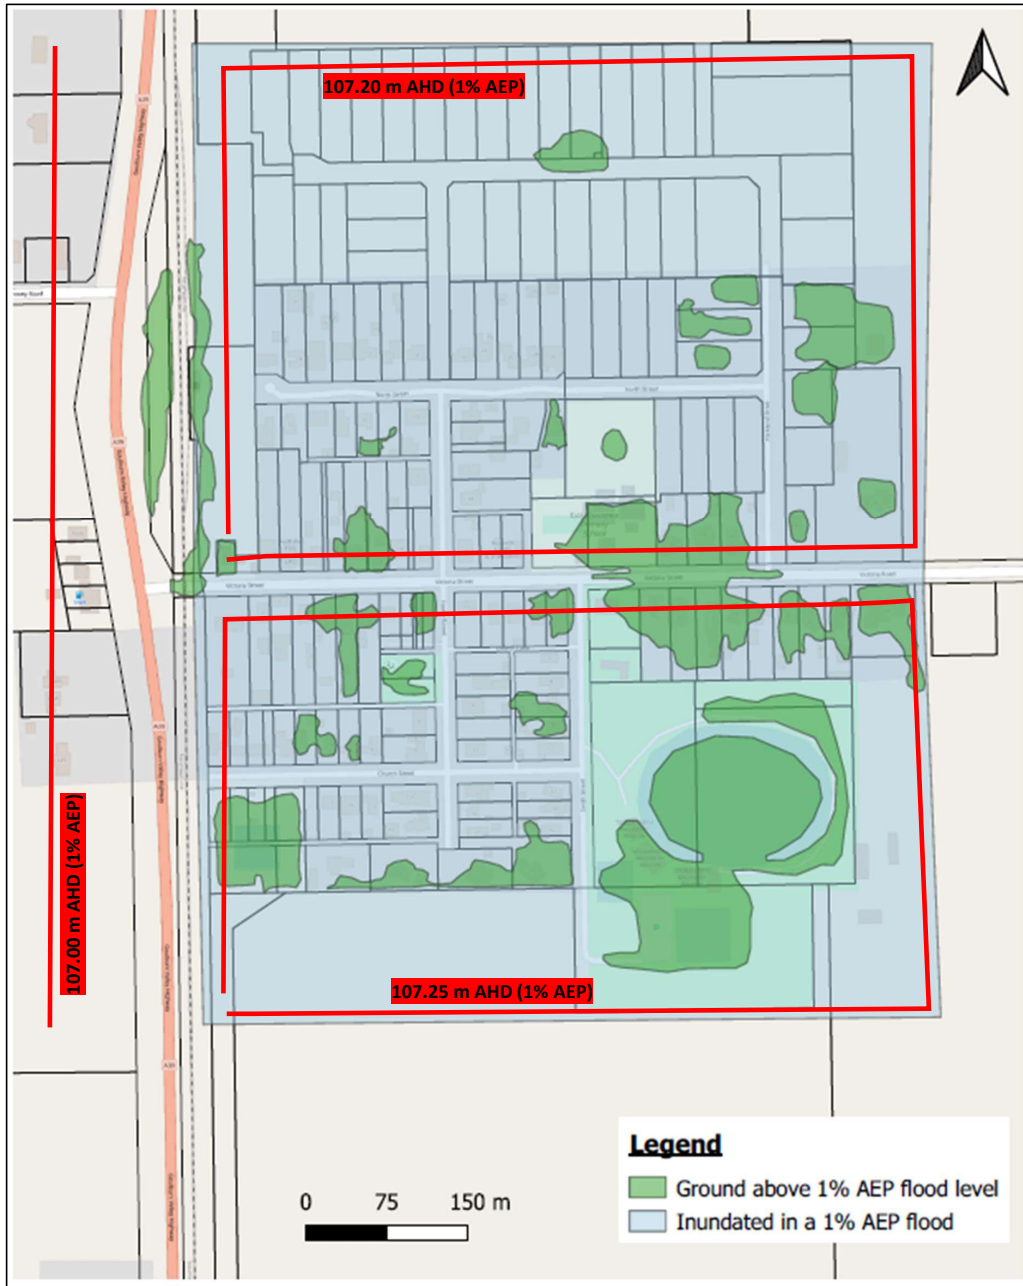
Figure 14 Tallygaroopna Township – 1% AEP Flood Extents and Heights

The current inundation mapping as depicted by the flood overlays (Floodway Overlay (FO) and Land Subject to Inundation Overlay (LSIO) around Tallygaroopna township is in need of updating. Specifically, the following is recommended:

- The floodway overlay extents in the vicinity of Congupna Creek to be adjusted such that it is positioned over the creek route.
- 1% AEP flood height contours over Congupna Creek to be adjusted as described in Section 5.4.5.
- 1% AEP flood height contour at Tallygaroopna township to be updated reflecting the 1% AEP flood heights nominated by this Scoping Study.
- LSIO extents at Tallygaroopna to be adjusted to reflect the inundation extents shown on Figure 14.
- The Daintons Creek floodway north of Thompsons Road to be deleted including the 1% AEP flood height contours along the floodway route.

Council and the Goulburn Broken CMA should consider adding the defined inundated areas shown on Figure 14 as new LSIO areas when the planning scheme overlays are next updated.

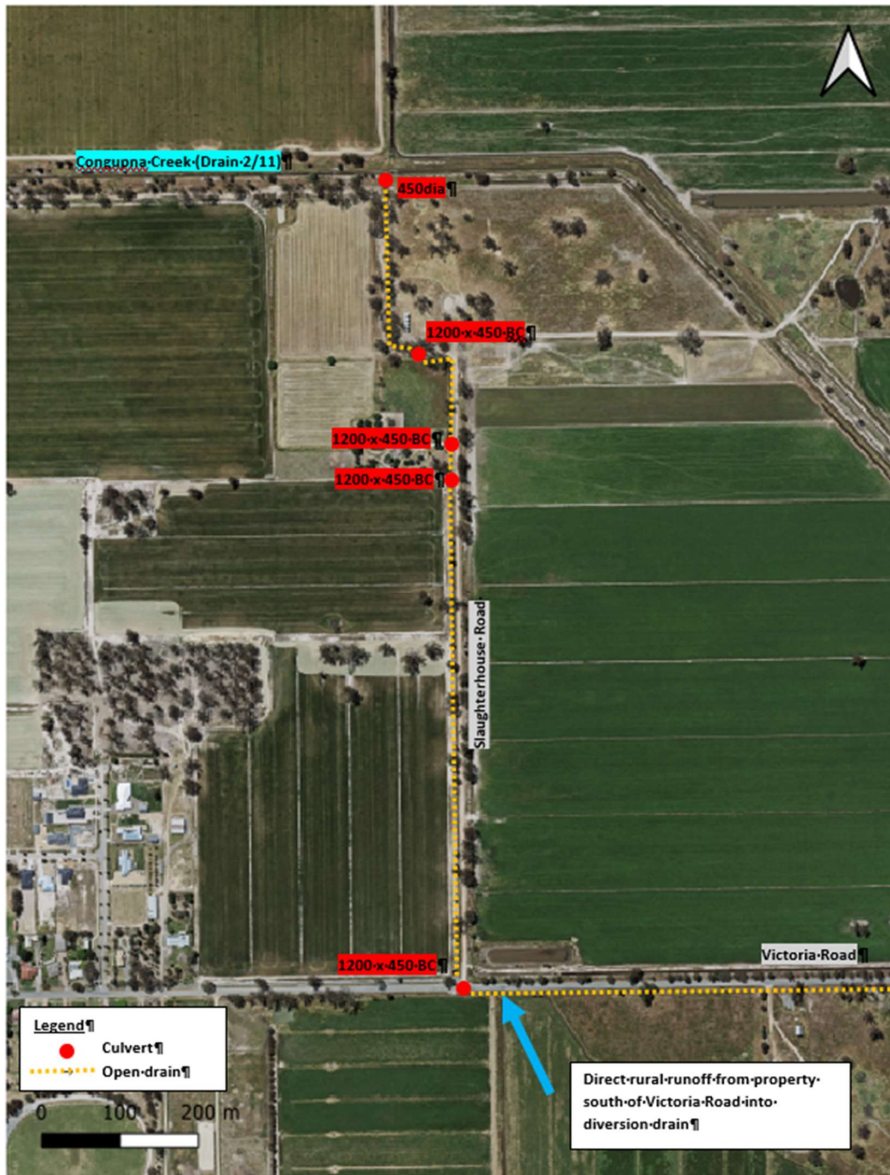
Figure 17 Slaughterhouse Road Diversion Drain

Culvert capacities along the drain route (1200 x 450 mm box culvert) are considered favourable.

No changes to the existing diversion drain are nominated. The drain could currently be better utilised if runoff from the property south of Victoria Road was able to access the drain.

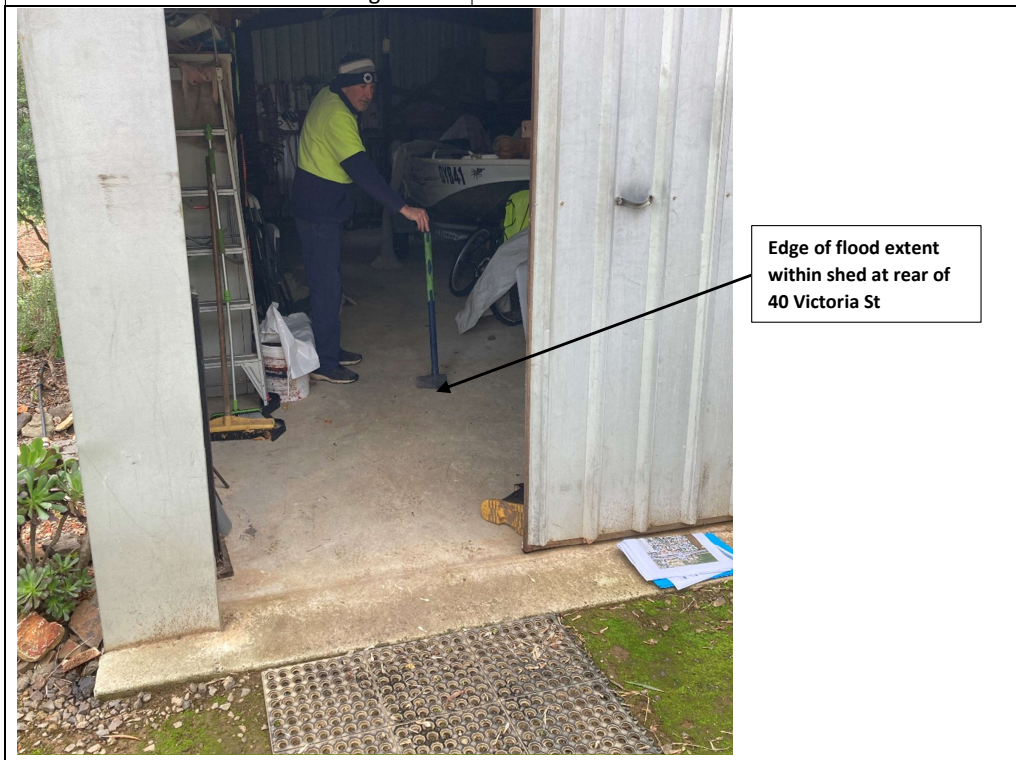
Flood Mark No.	FM2023 – T1
Date of interview / Inspection	27 June 2023
Address	40 Victoria Street
Flood Description	2012 flood - where floodwaters got to on the concrete floor of this rear shed.
Reliability	Medium
Flood Level (m AHD)	107.18
MGA Zone 55 Coordinate - easting	359627
MGA Zone 55 Coordinate - northing	5988489

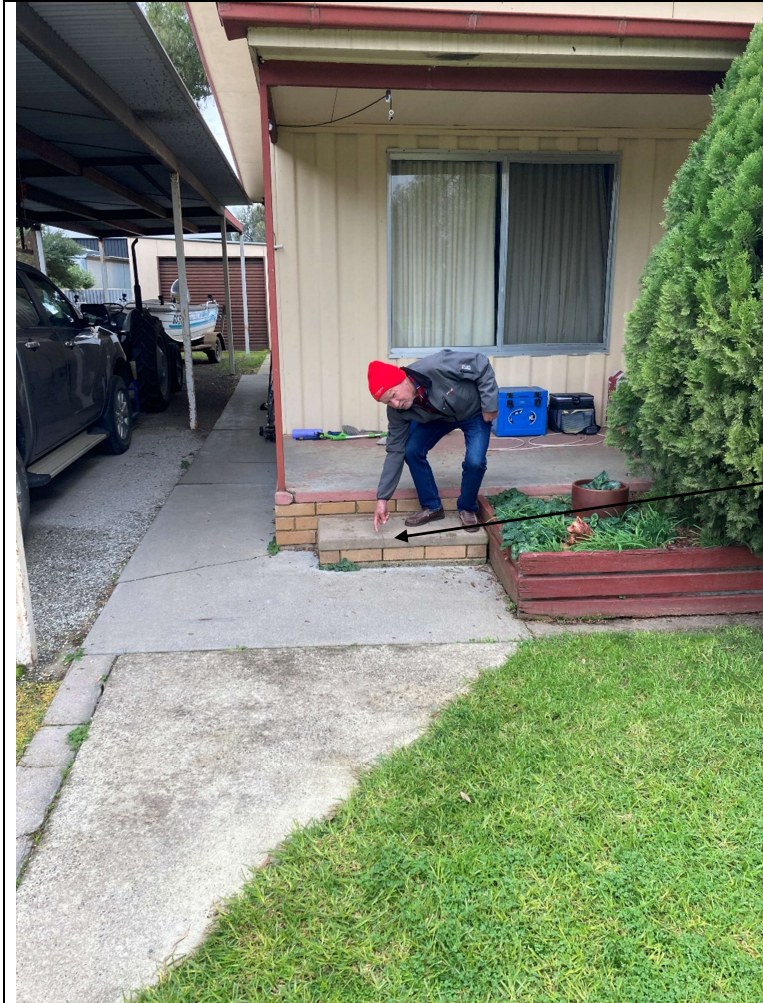
Top of step at 8 Church St

Flood Mark No.	FM2023 – T3
Date of interview / Inspection	27 June 2023
Address	8 Church Street
Flood Description	Peak 2012 flood level equal to the top of the first step up the verandah leading to the house front door.
Reliability	Medium
Flood Level (m AHD)	359169
MGA Zone 55 Coordinate - easting	5988262
MGA Zone 55 Coordinate - northing	107.27

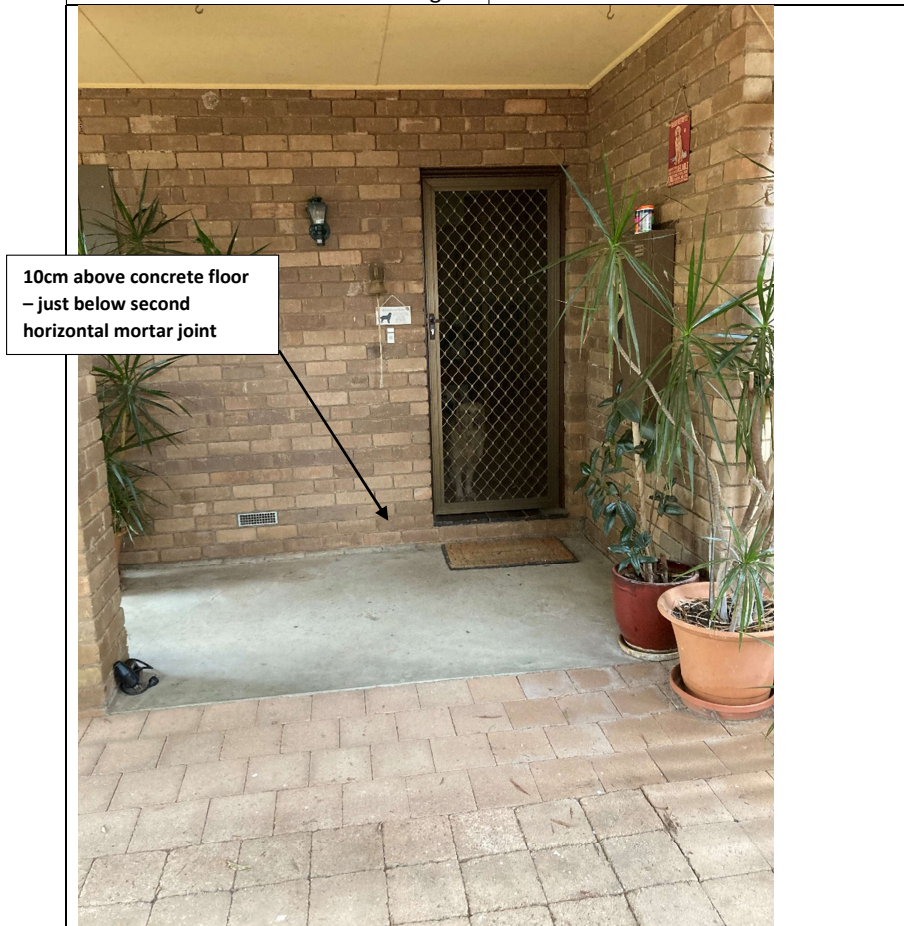
Flood Mark No.	FM2023 – T4
Date of interview / Inspection	30 June 2023
Address	12 North Street
Flood Description	Peak 2012 flood level. Flood level peaked just below the second horizontal brick mortar line above floor (10 cm above concrete floor) to left of the front door.
Reliability	High
Flood Level (m AHD)	107.17
MGA Zone 55 Coordinate - easting	359300
MGA Zone 55 Coordinate - northing	5988631
