Flooding Behaviour - Mooroopna ODP

**Report Prepared For
City of Greater Shepparton**

**Report LJ5470 / RM2125
April, 2007**

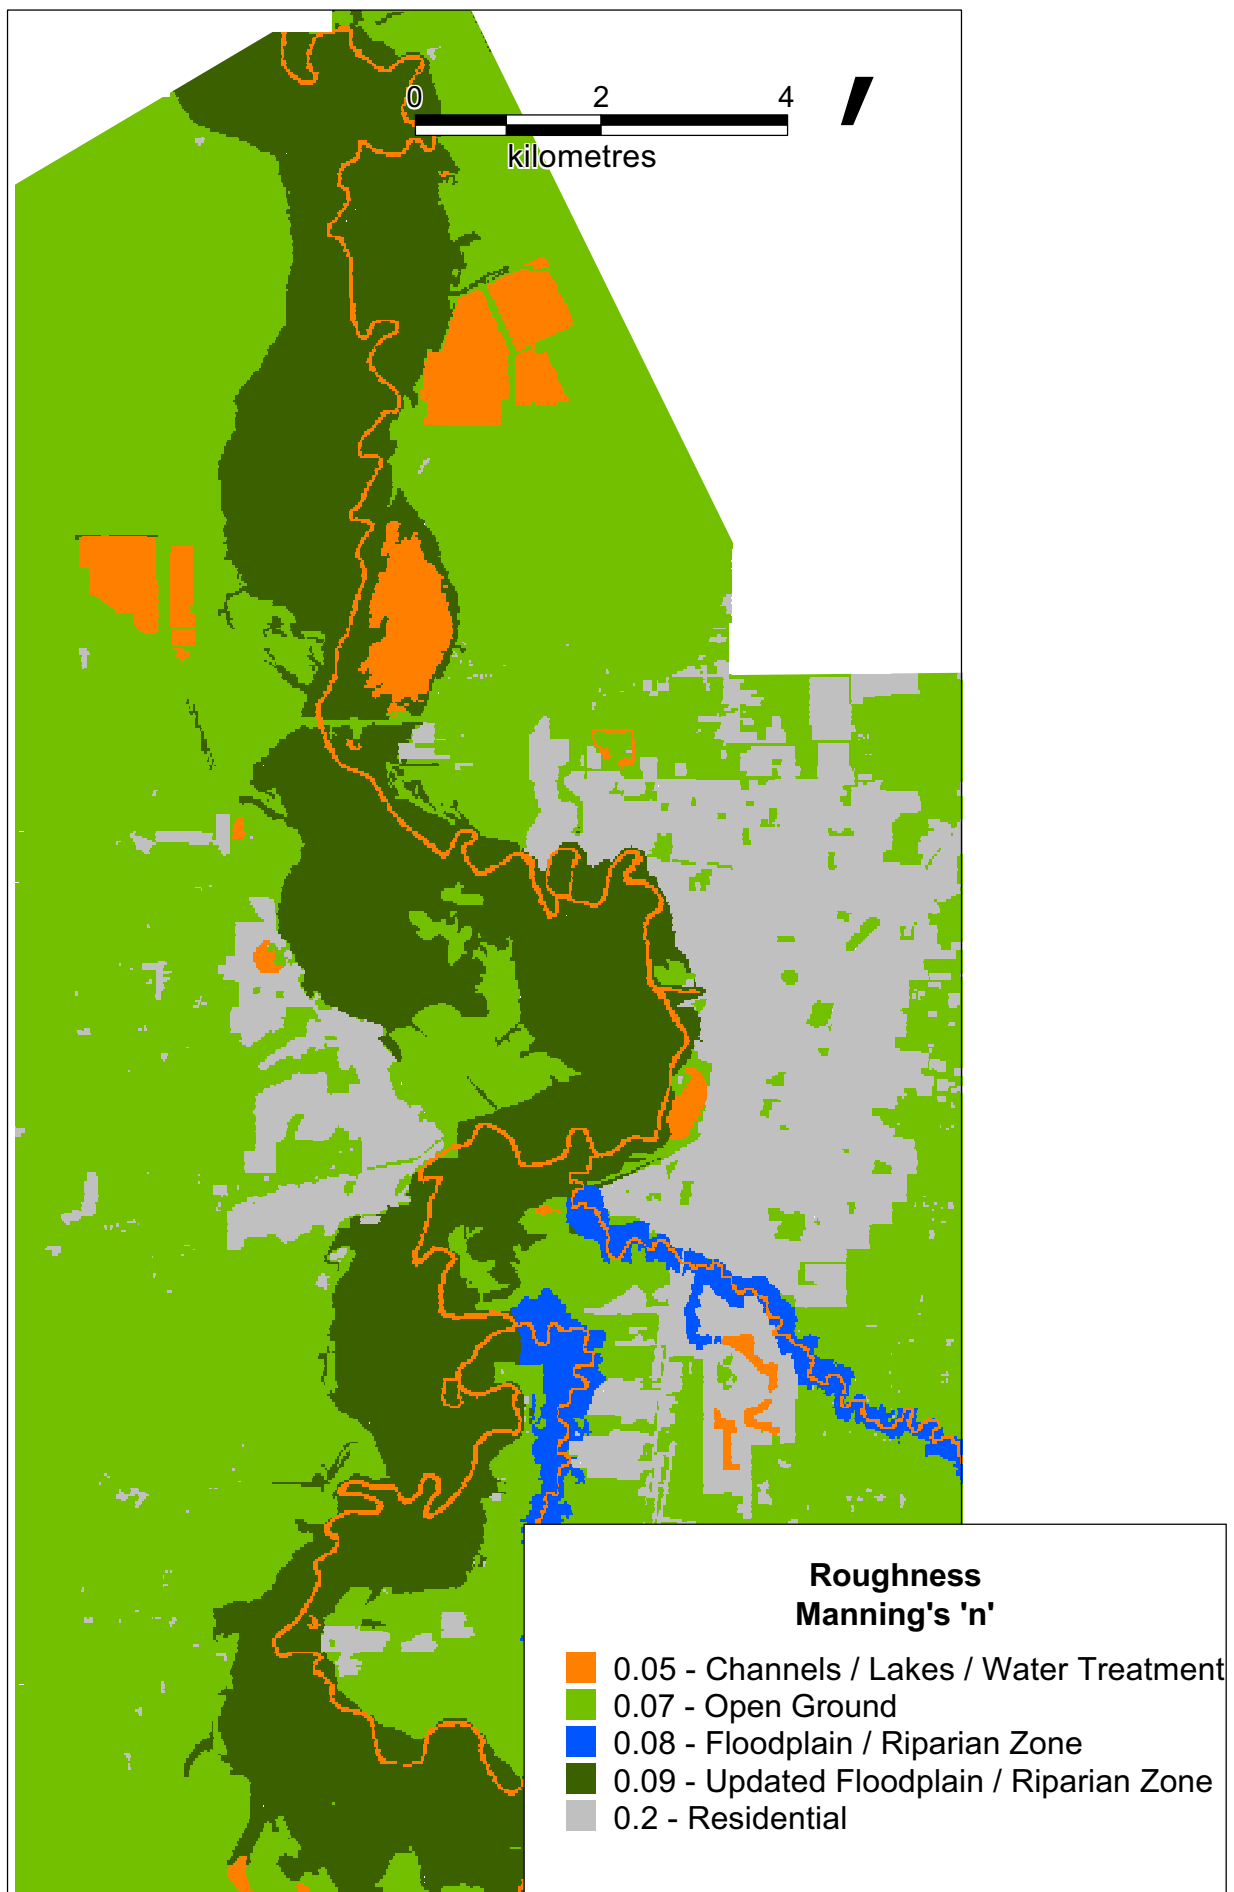
Figure 4 - Roughness, 2005 Conditions

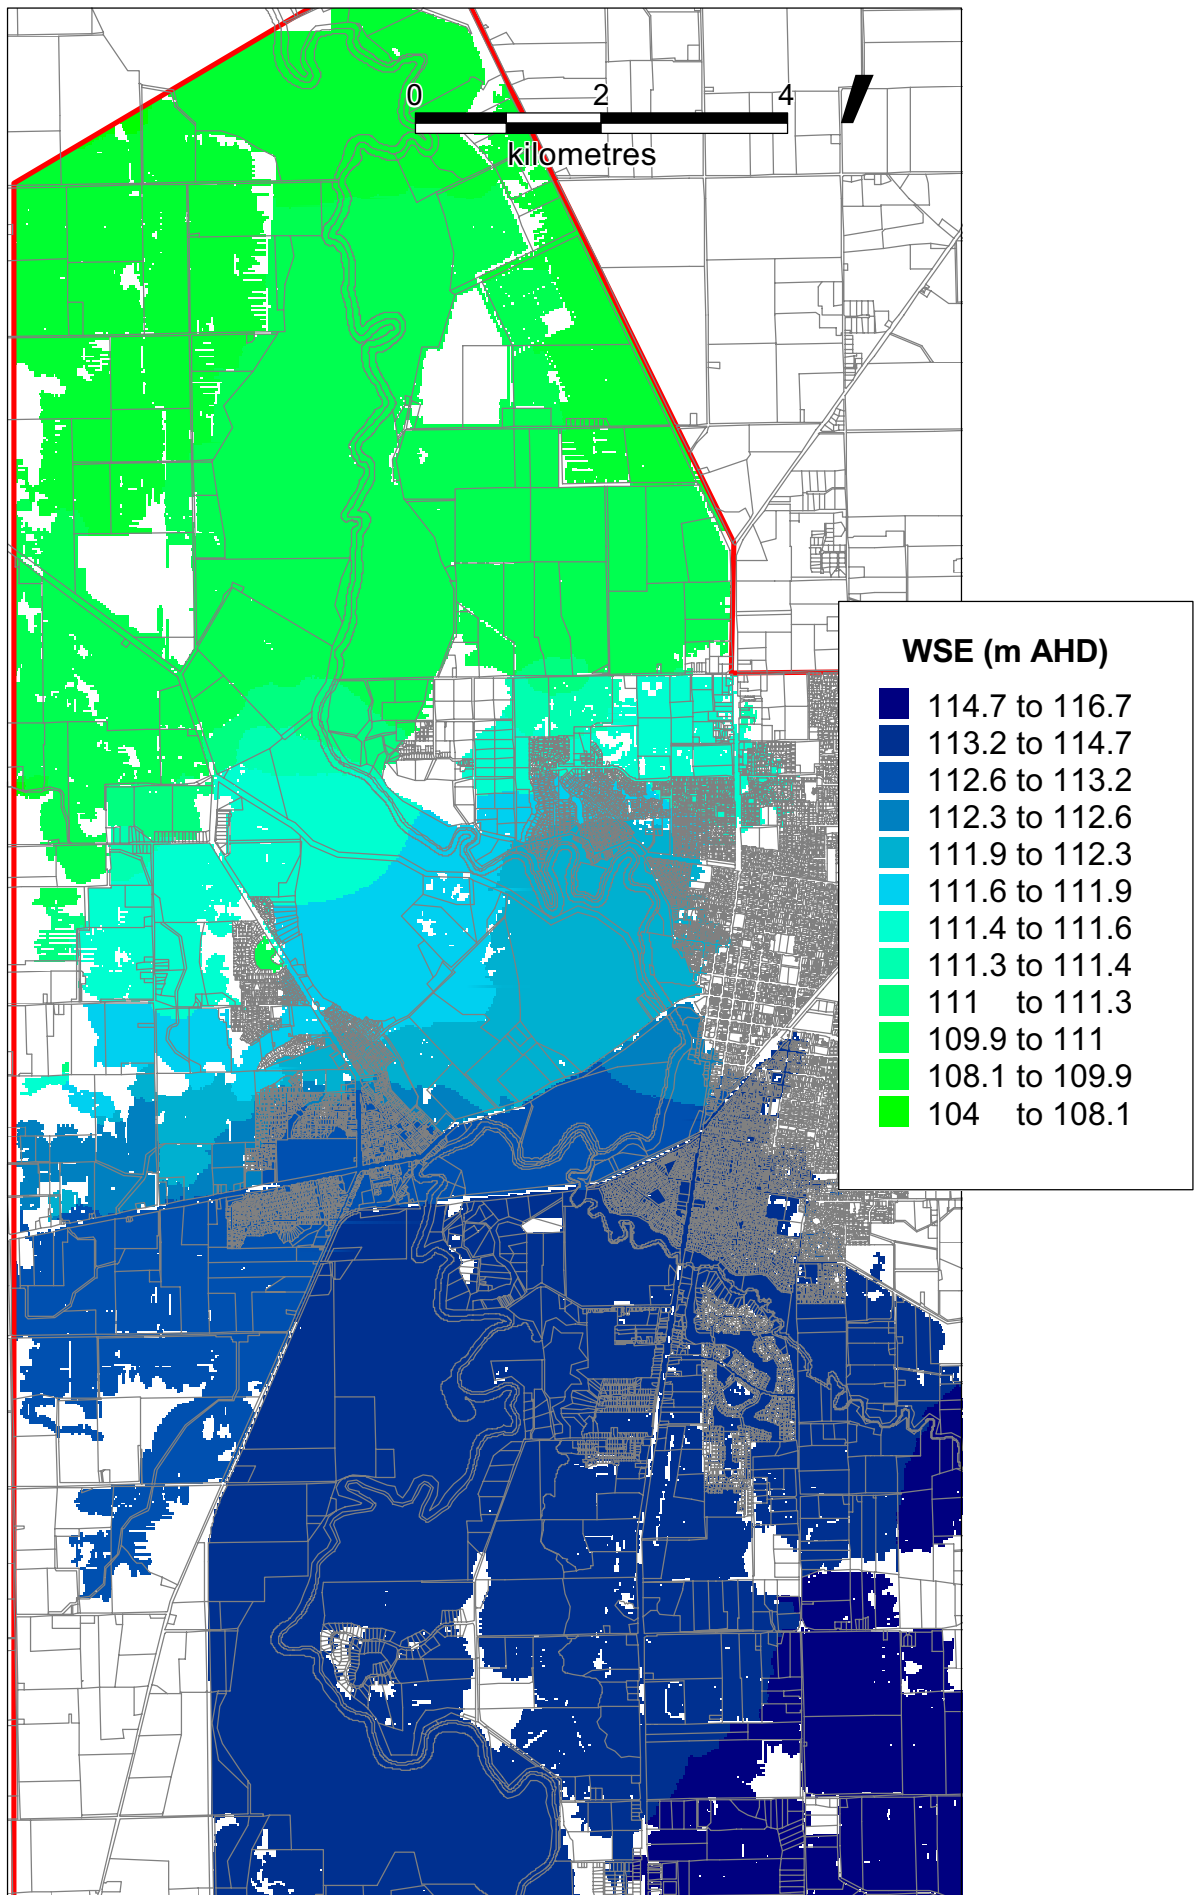
Figure 5 - 2005 Existing Conditions, 100 Year ARI Maximum Water Surface Elevation

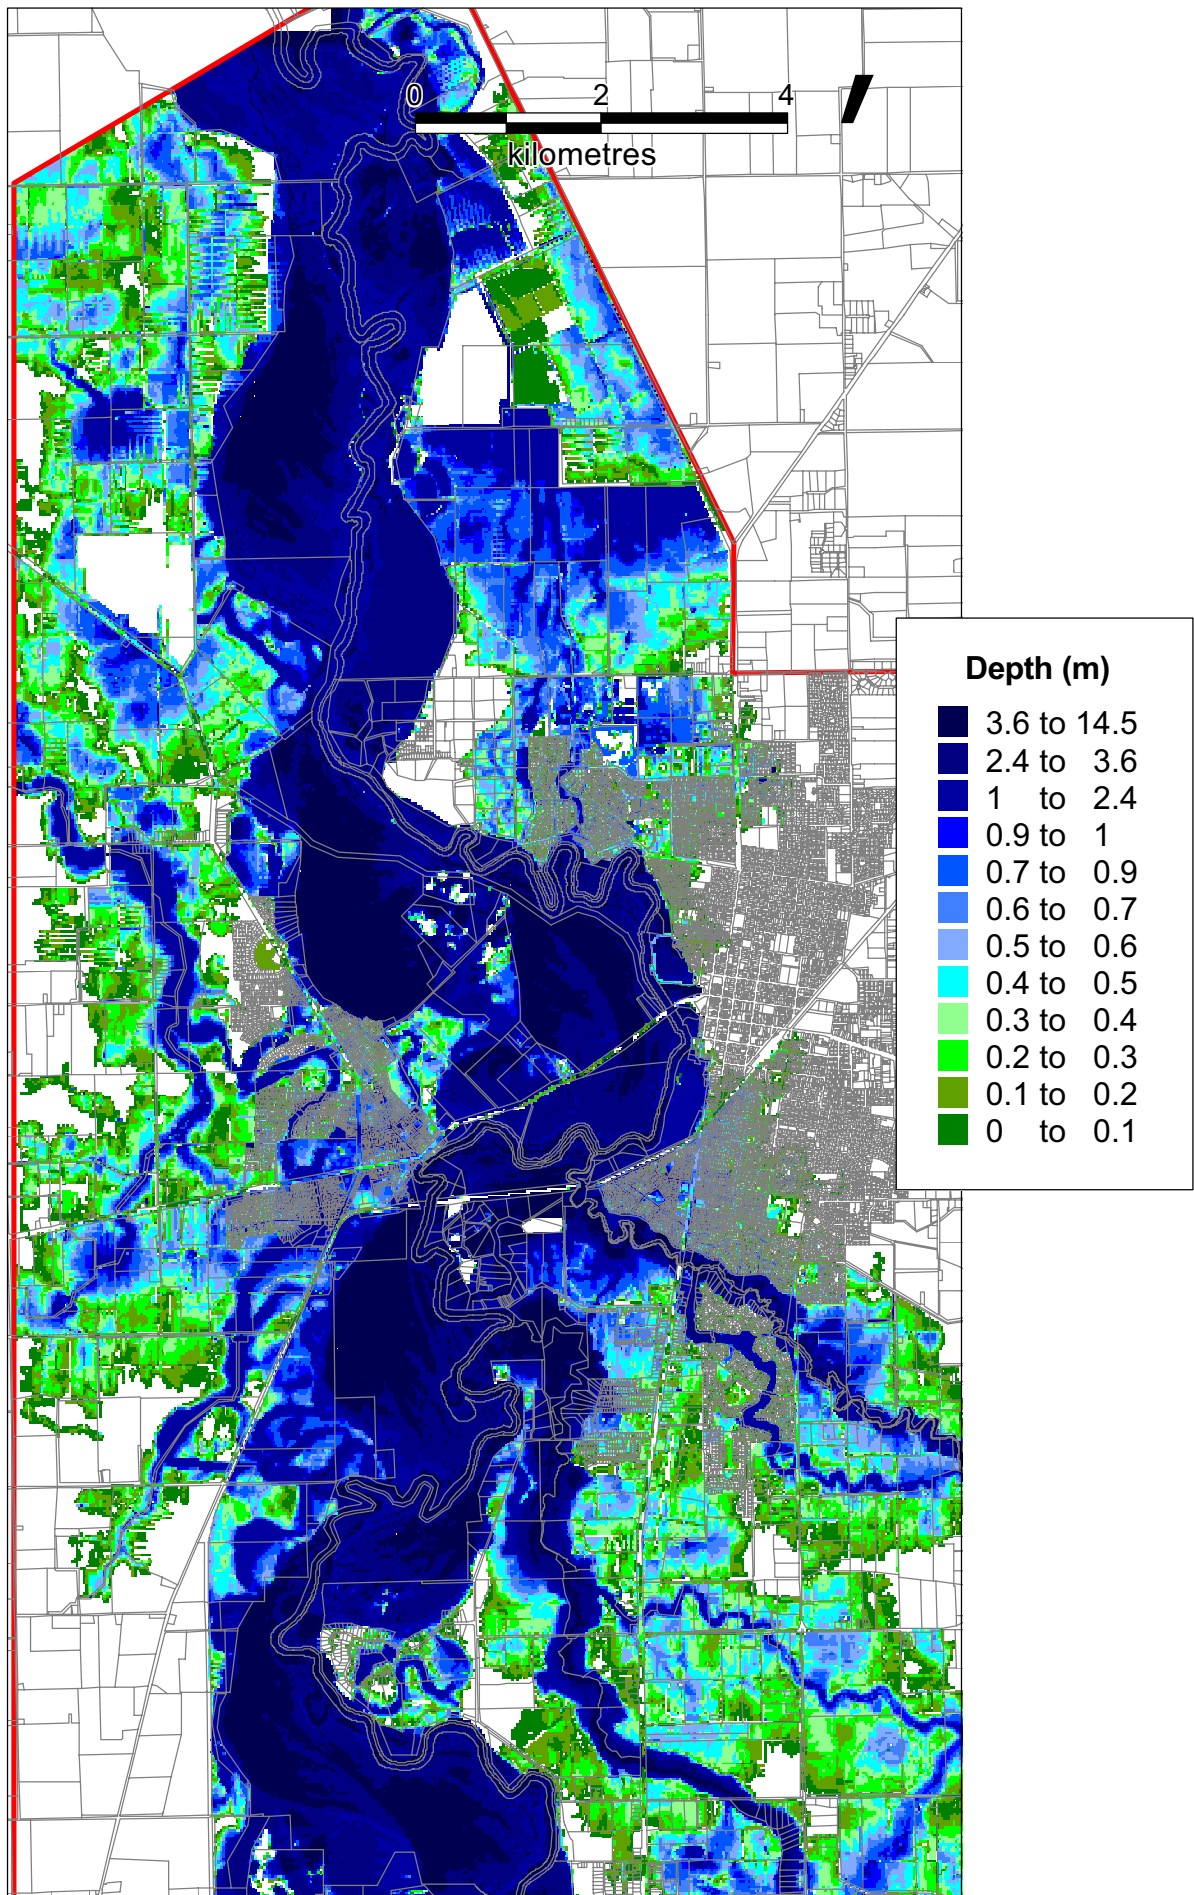
Figure 6 - 2005 Existing Conditions, 100 Year ARI Maximum Water Depth

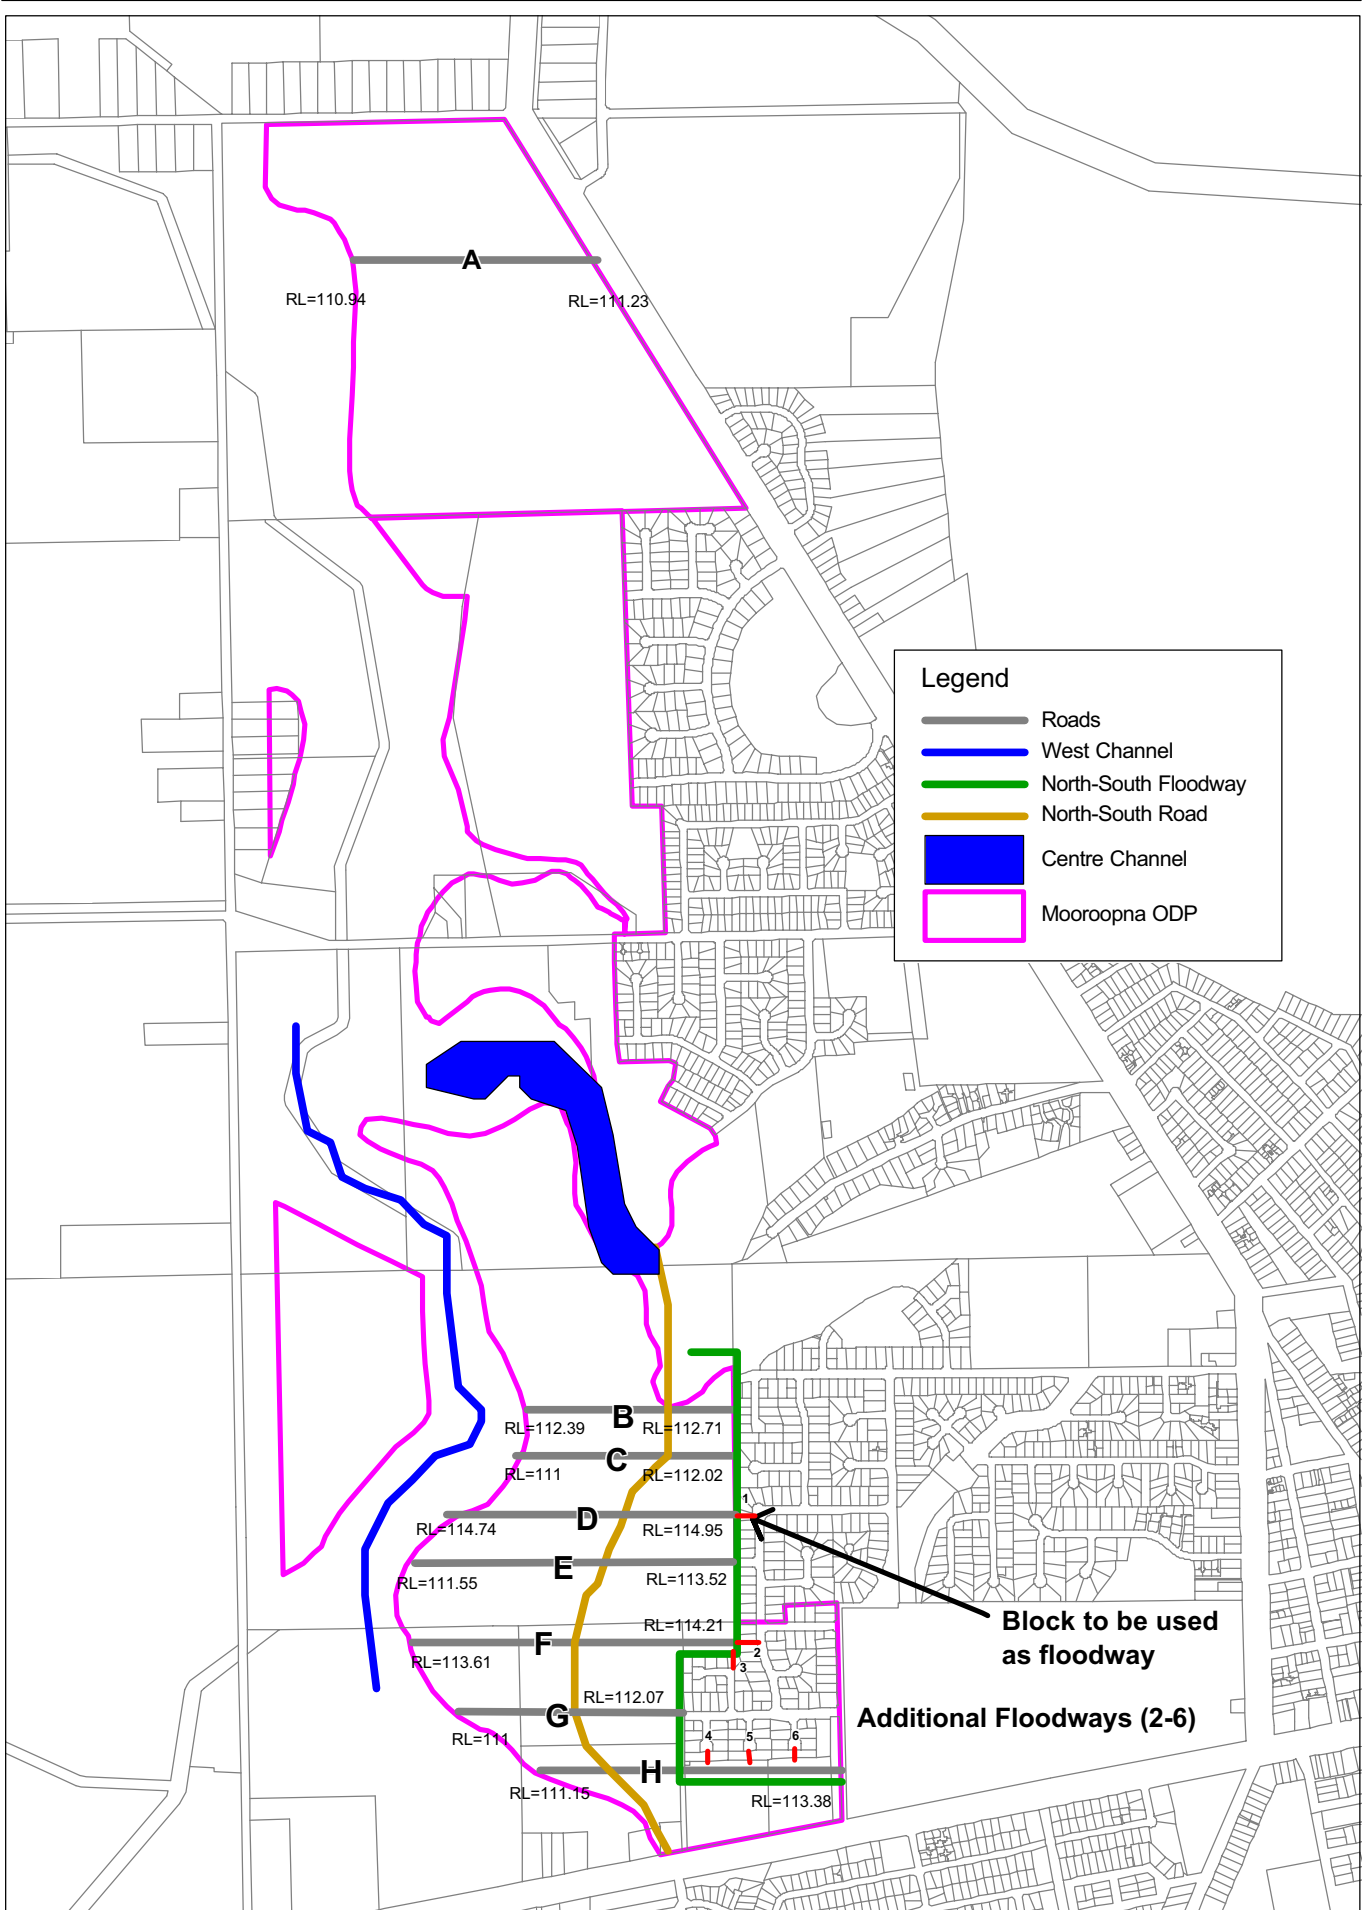
Figure 7 - Topographical Features Within the Mooroopna ODP

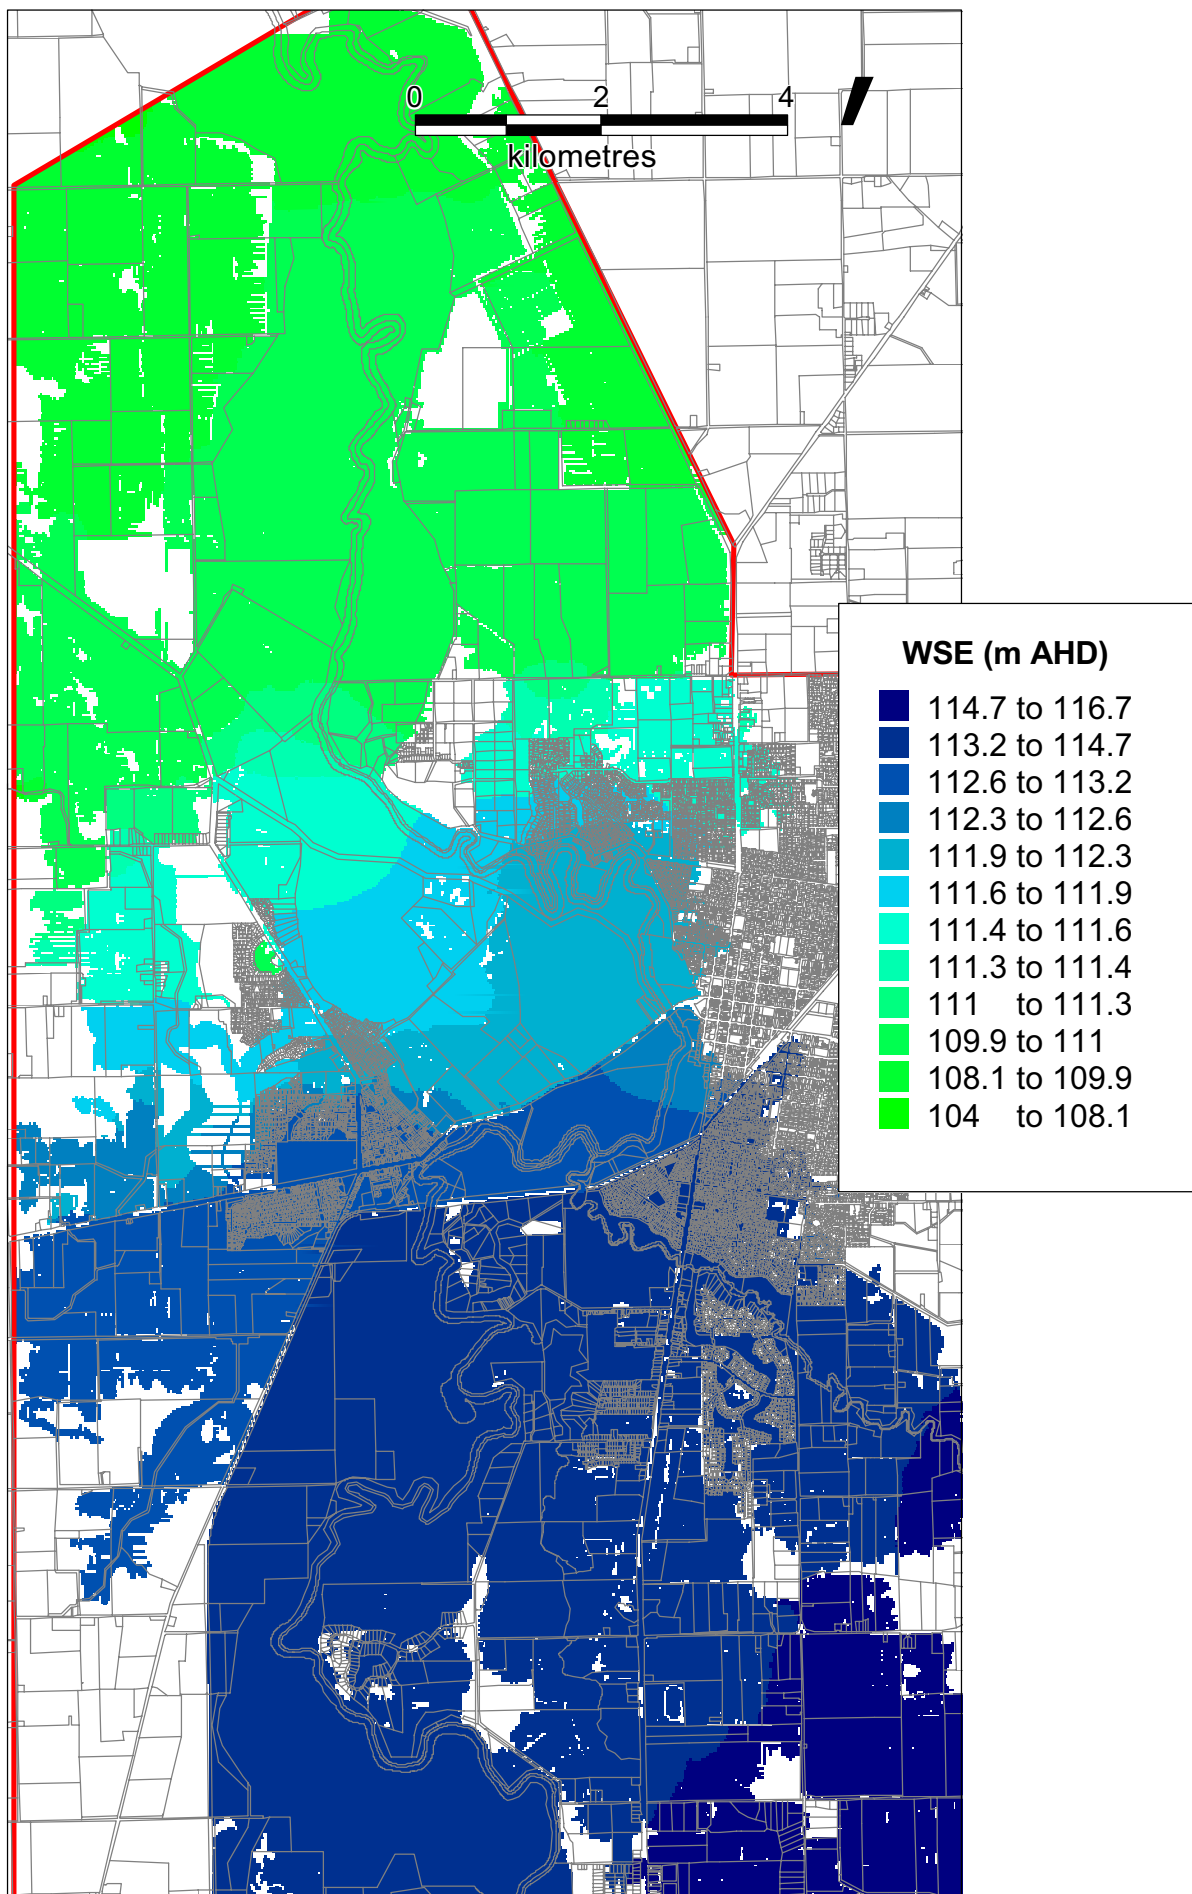
Figure 8 - 2005 Mooroopna ODP, 100 Year ARI Maximum Water Surface Elevation

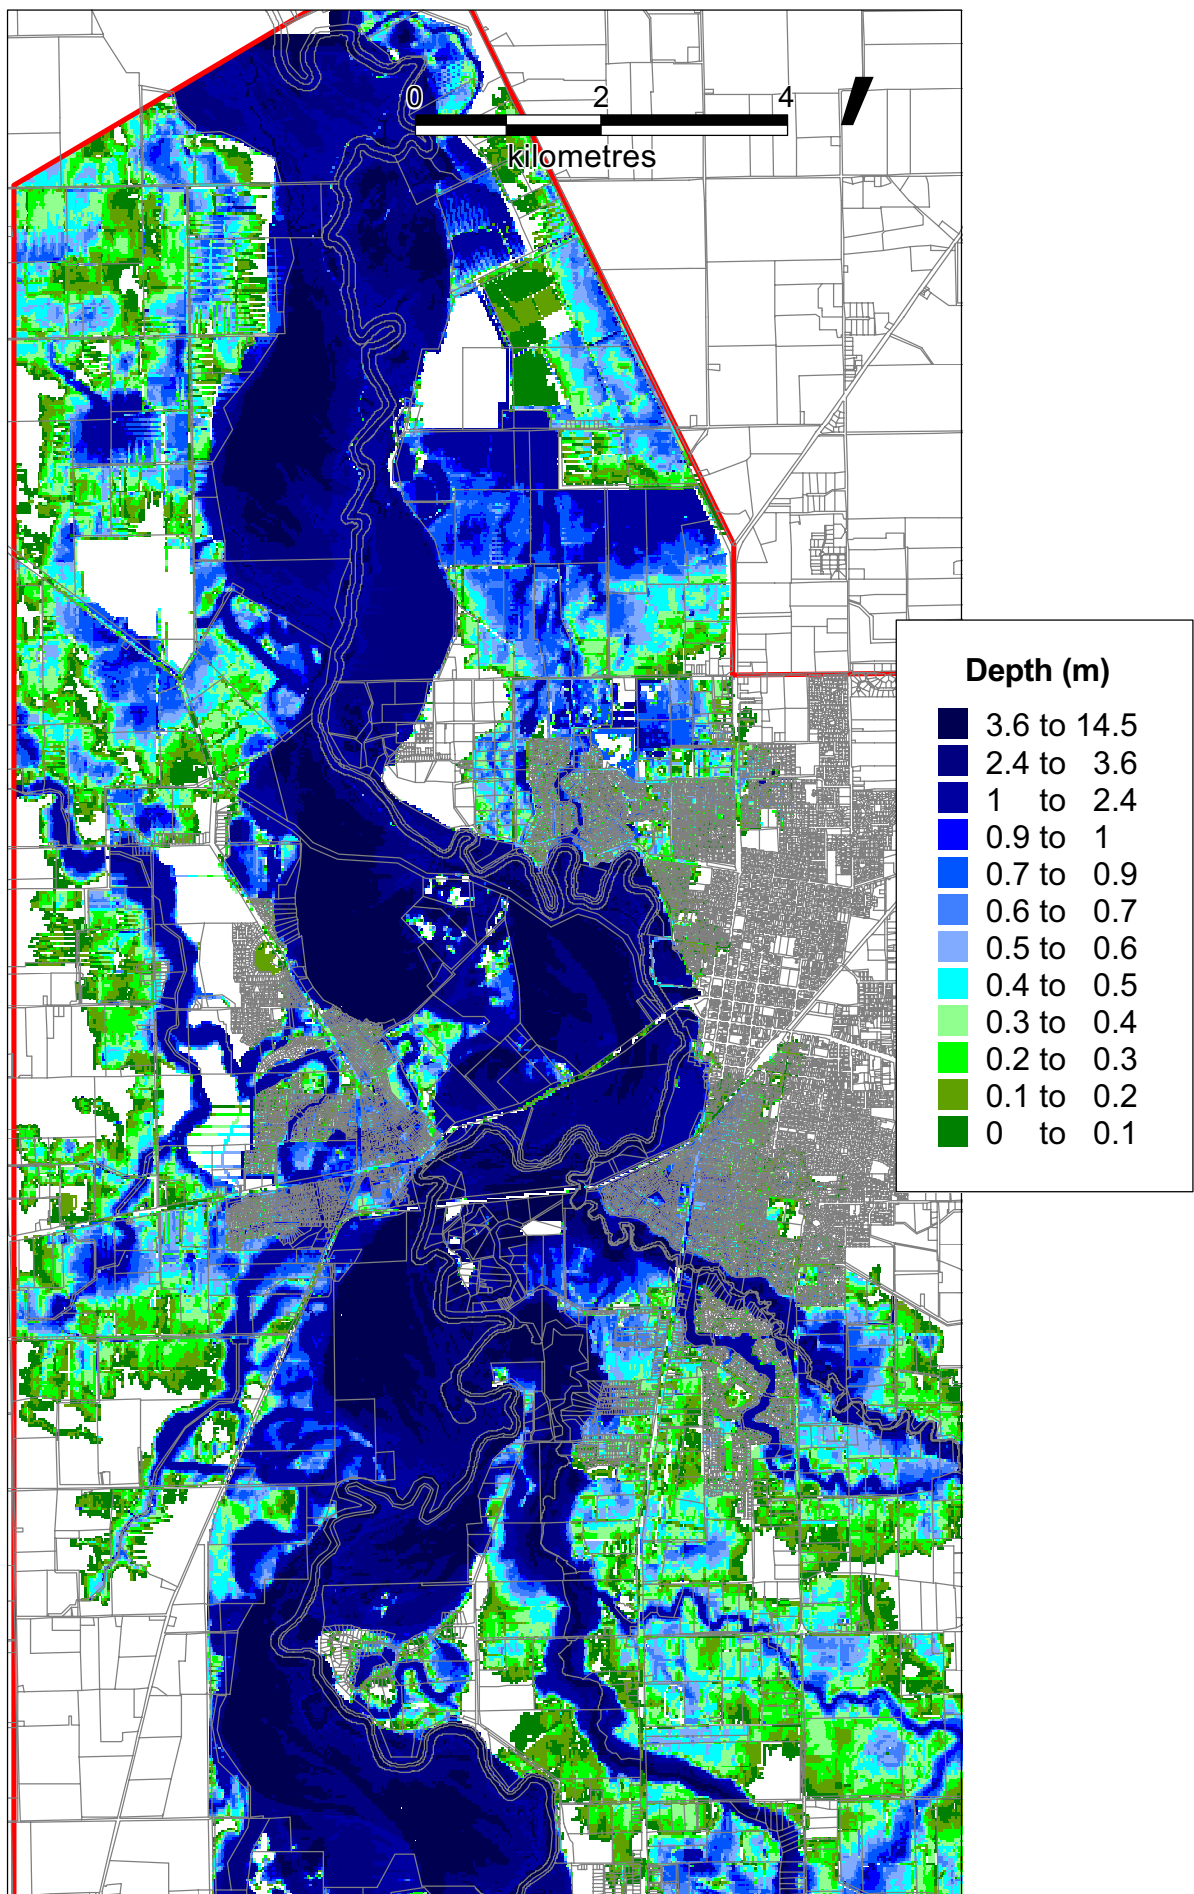
Figure 9 - 2005 Mooroopna ODP, 100 Year ARI Maximum Water Depth

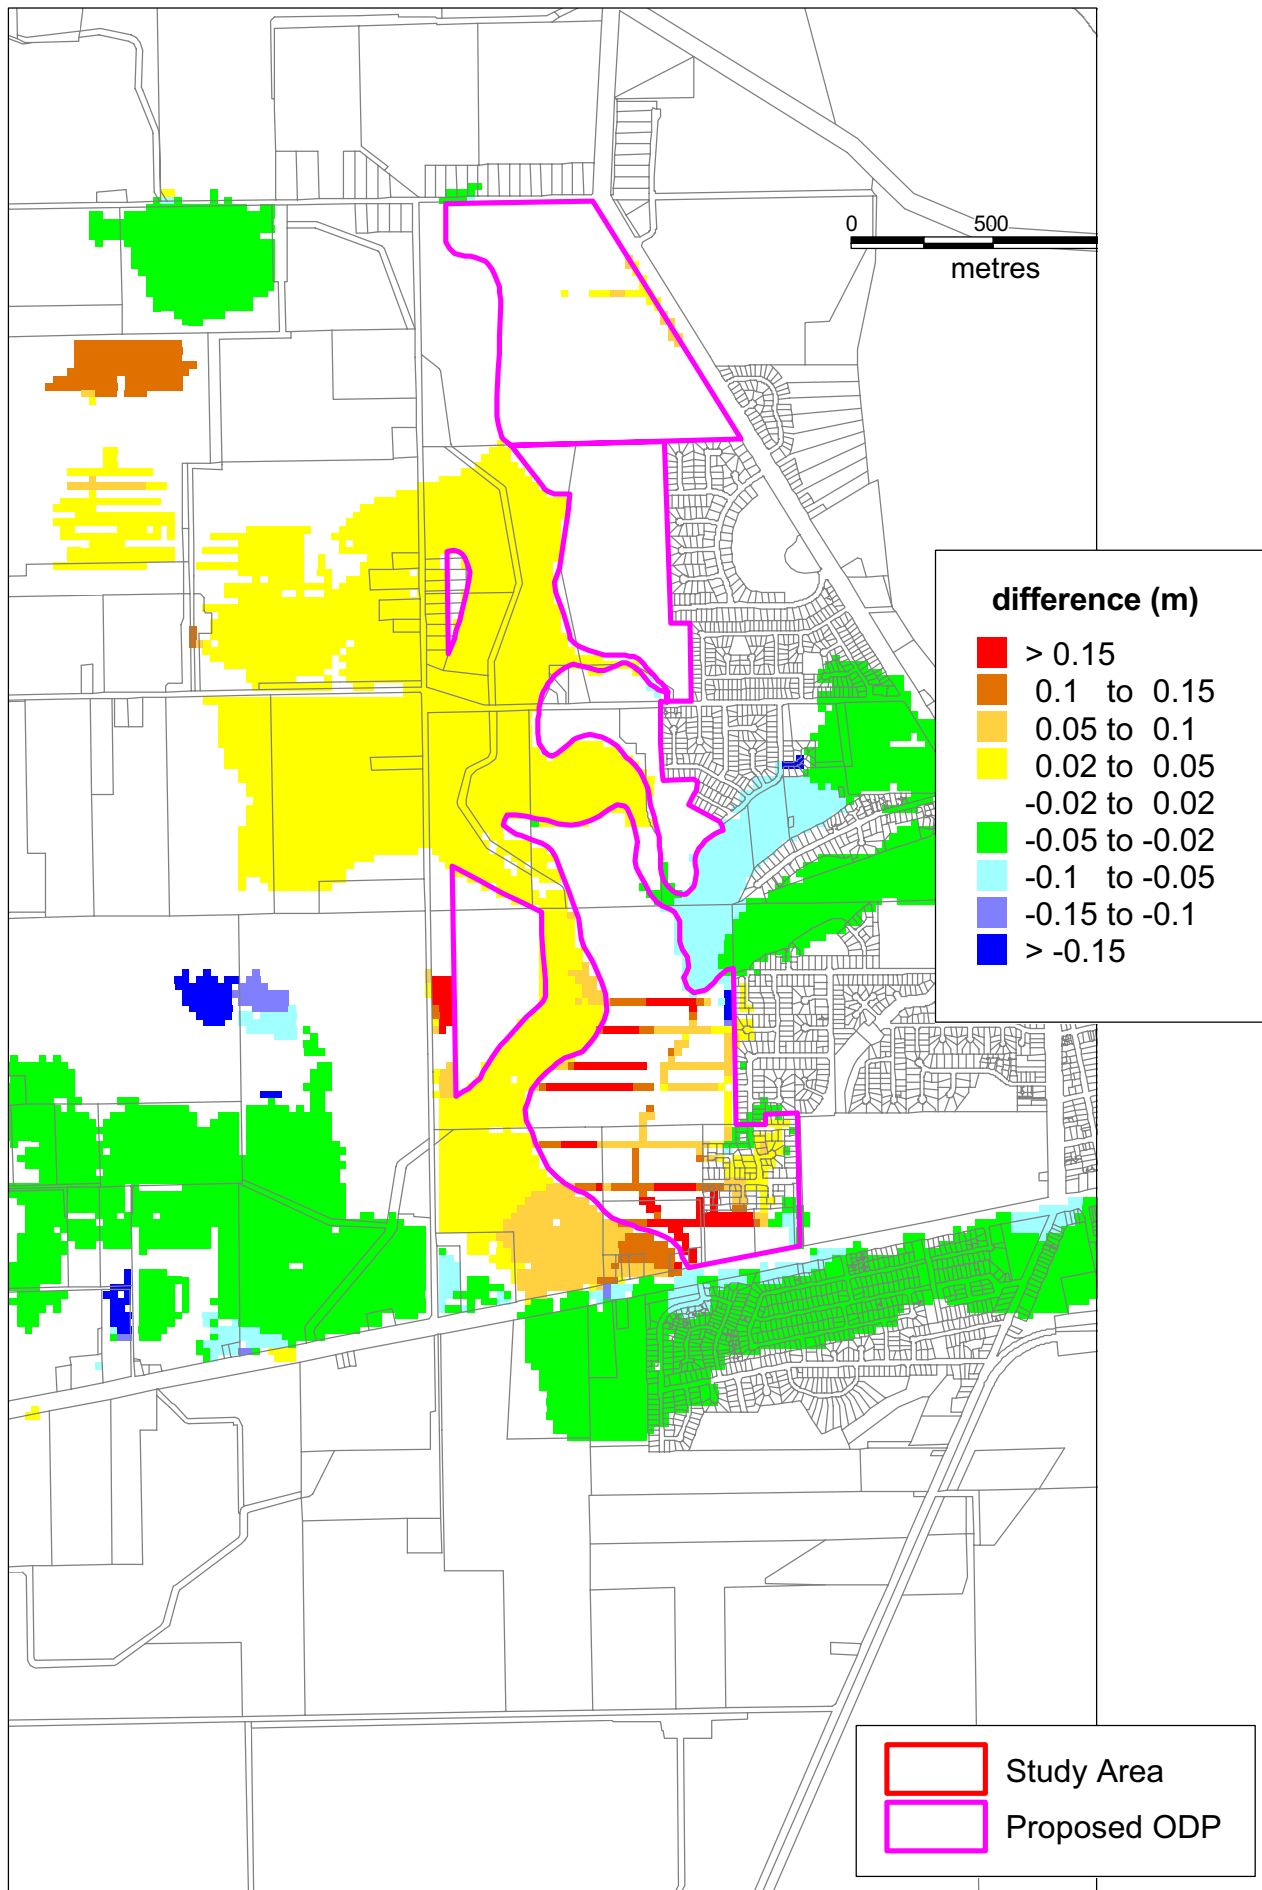
Figure 10 - WSE Difference - ODP Minus 2005 Conditions, 100 Year ARI Event
